Inspection Report

123 Main Street
Anytown MA

Still River Home Inspections, Inc.

| Date: 10/23/2017 | Time: 09:00 AM - 12:00 PM | Report ID: 082817 sample |

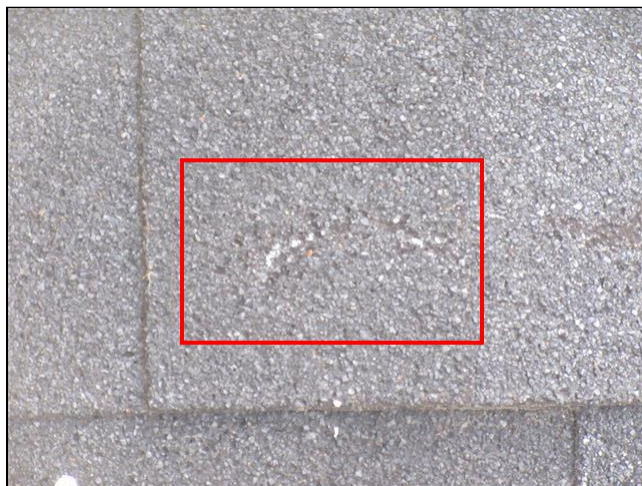
(2) There was wear on the roof likely caused by a person removing snow and ice. There were water stains on ceilings in the house, likely from leaks from ice dams. Improvements in the energy efficiency and ventilation of the attic may reduce the chance of issues, see Insulation and Ventilation section later in this report. If leaks from ice dams are found to be a problem, a qualified contractor should remove snow from the roof before ice dams can form. I recommend monitoring the roof for excessive snow and ice build up.

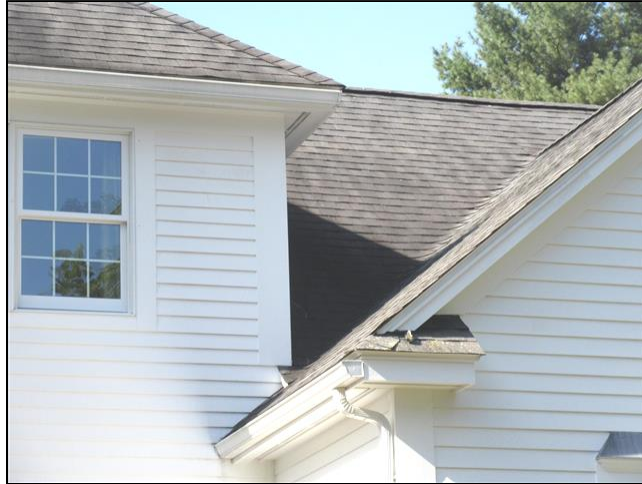
(3) There was a complex section of roof at the front of the house that may trap snow in winter. There is the potential for leaks from ice dams. I recommend monitoring this area for excessive snow and ice build up.

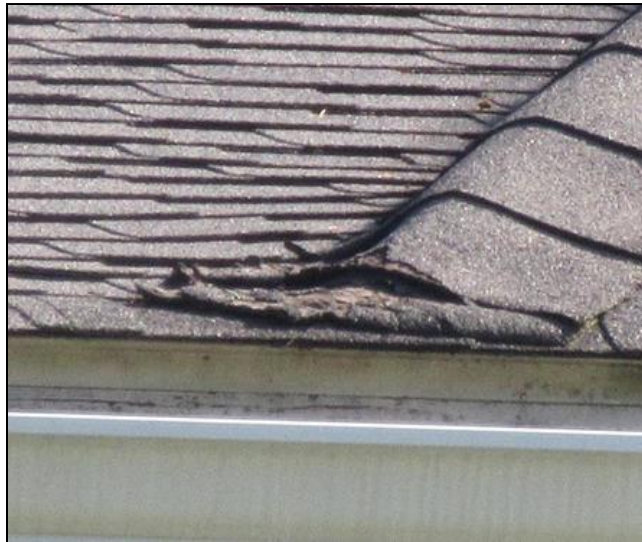
(4) There were deteriorated ridge shingles at the back of the house. There is the potential for leaks. A licensed roofer should replace these shingles.

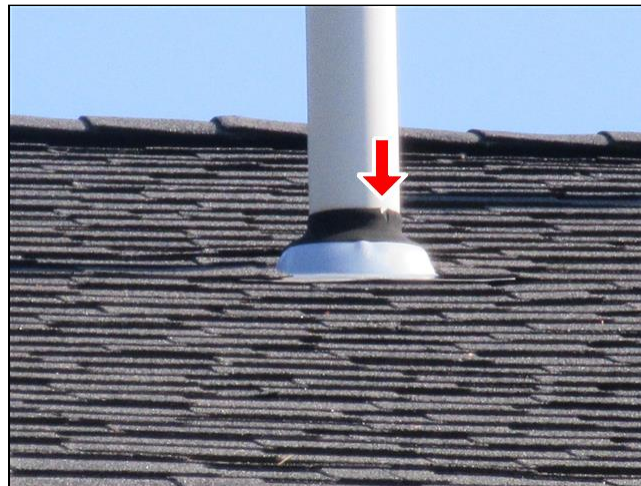
🔧 (2) There was a split in the rubber boot at the plumbing vent flashing. There is the potential for leaks. The best time to replace plumbing vent flashing is when the roof is replaced. In the meantime, the flashing can be repaired with a product called Perma-Boot which eliminates the need to re-shingle around the plumbing vent after the repair.

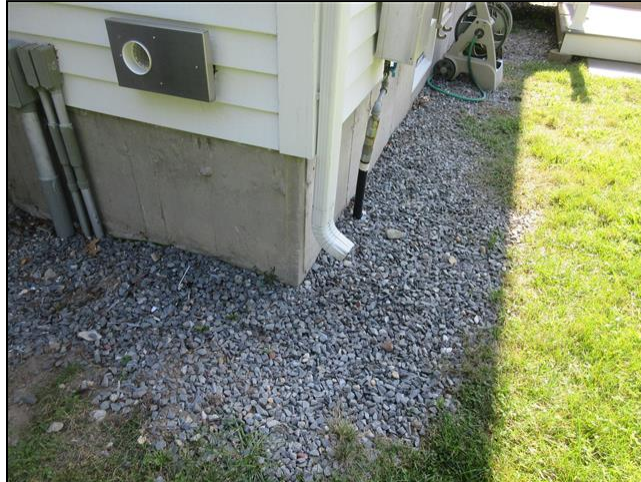
🔧 (1) The downspout extensions were missing. Downspouts carry roof water to the ground and should have extensions that direct the water to an appropriate distance, 5 or 6 feet, from the foundation. If there are no downspout extensions, or if the extensions are too short, the roof water may eventually end up in the

basement. Proper downspout extensions should be installed to carry the water to an appropriate distance from the house.

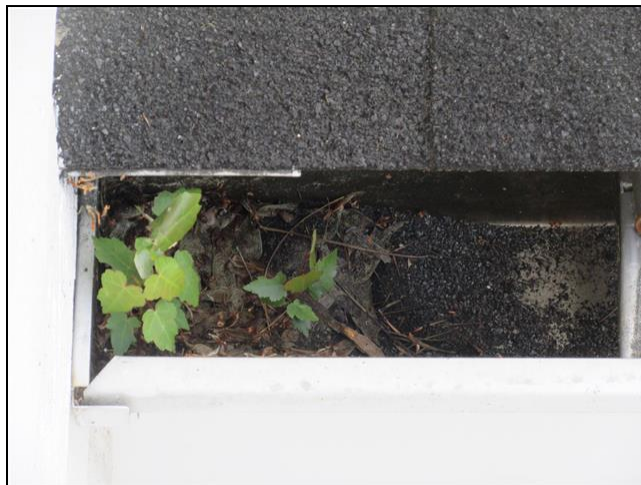
🔧 (2) There was debris in the gutters. The gutters should be cleaned out twice a year. One cleaning should occur late in the spring and the other late in the fall.

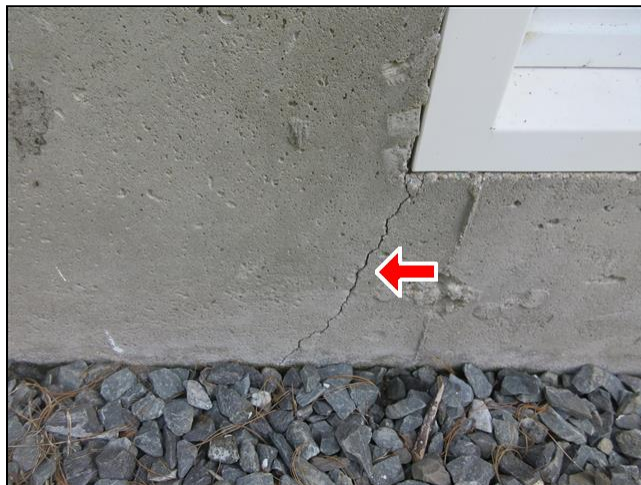
There were cracks in the foundation. The cracks should be monitored for moisture intrusion and further movement.

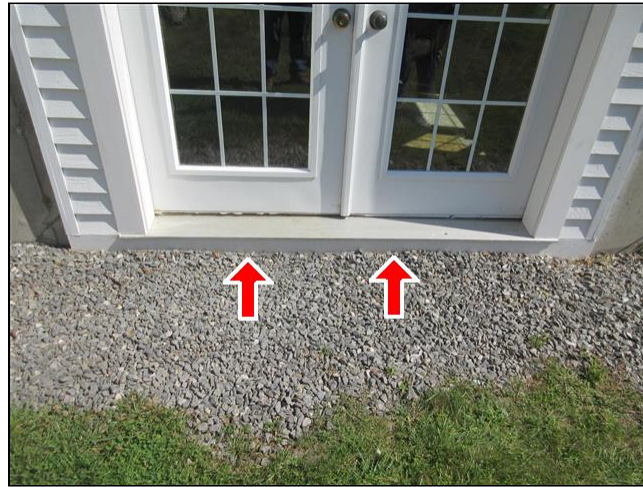
🔧 (1) Wood was in contact with the ground at the french doors at the back of the basement. Wood in contact with the ground decays and is easy access for wood destroying insects. A qualified contractor should remedy this situation.

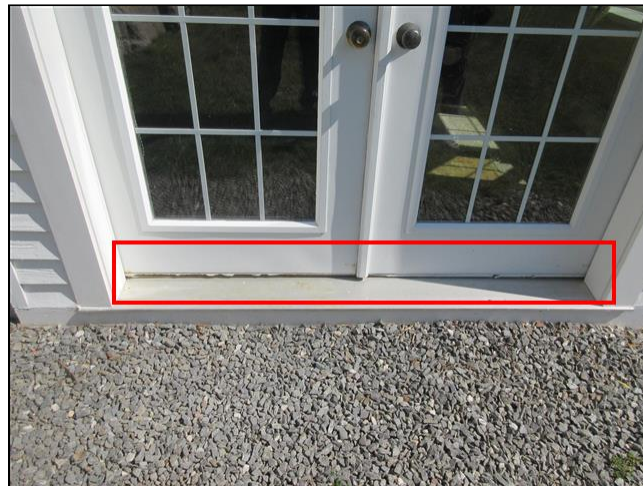
🔧 (2) The weather stripping at the french doors at the back of the basement was deteriorated. A qualified contractor should repair or replace the weather stripping.

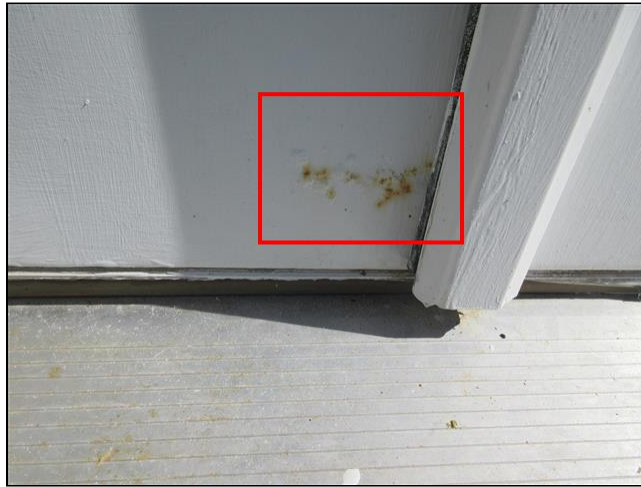
🔧 (3) The steel at the french doors at the back of the basement was rusting through the paint. The doors should be wire brushed, primed with paint designed for rusty metal, and painted with a finish coat designed for metal.

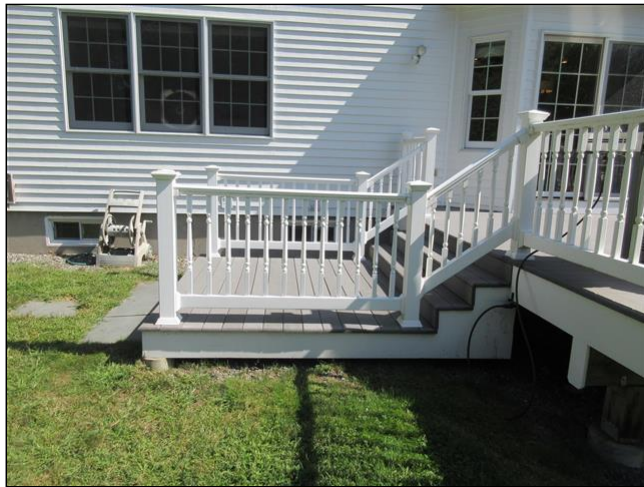
The ledger board at the upper deck was bolted to the house rim joist at the overhang at the back of the house. Due to the overhang, the house rim joist is not supported on a concrete foundation or studs in a wall. Instead the house rim joist is nailed into the ends of house floor joists. This connection is not sufficient to support heavy loads on the deck. Concrete piers and posts should be installed under this area.

I recommend that a qualified contractor complete these repairs.

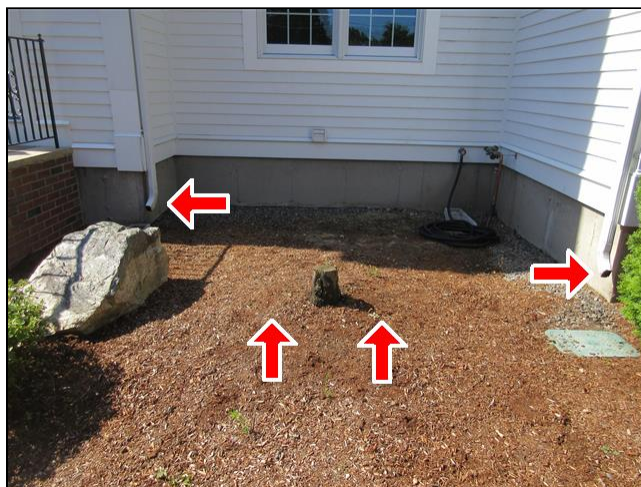
There was reverse grading at the front of the house. Proper grading sends water away from the house. Reverse grading allows water to flow towards the foundation, and this excess water may eventually end up in the basement. The land should slope away from the house at least 1 inch per foot for the first 6-10 feet. I recommend that a landscape contractor regrade this area. Downspouts discharged into this area. I recommend that a landscape contractor install underground drains for these downspouts.

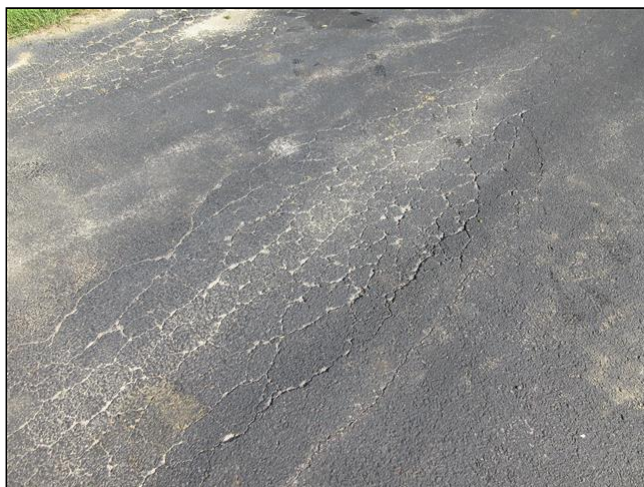
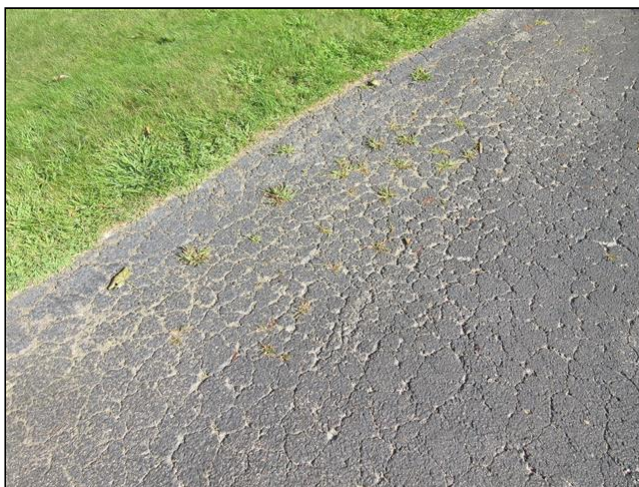
(1) The driveway was cracked and deteriorated. I recommend planning for replacement of the driveway.

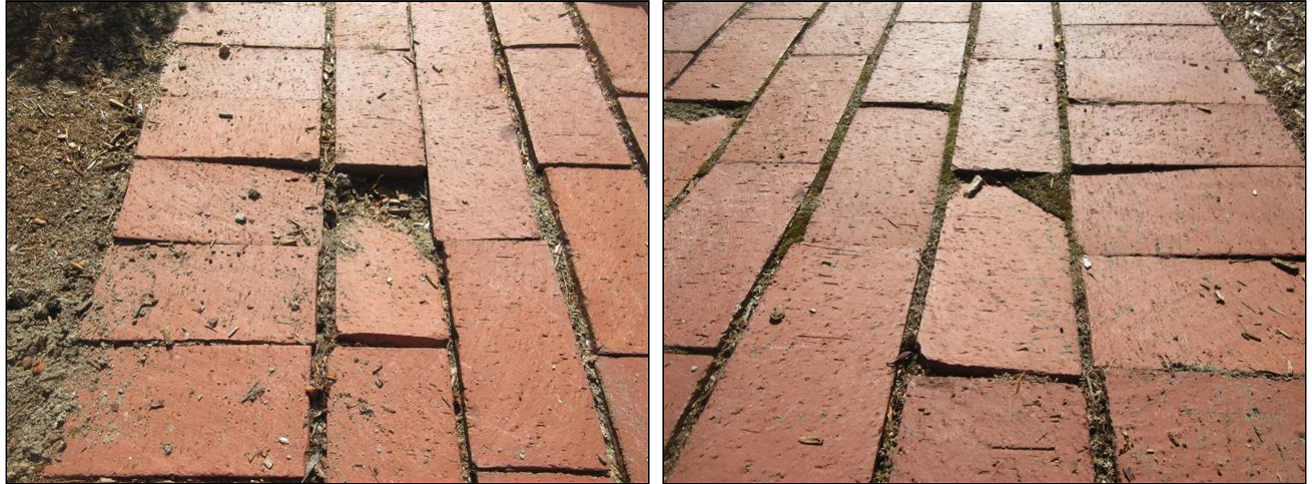
+ (2) There were raised edges in the brick walk at the front of the house. This is a trip hazard. A landscape contractor should repair this walk.

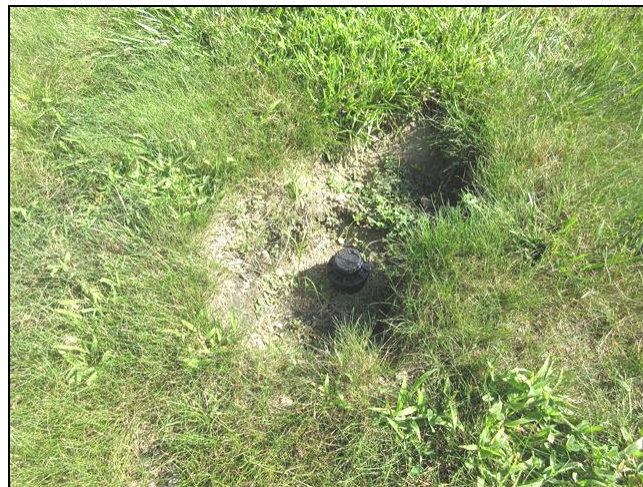
+ (1) There was a hole in the backyard for a sprinkler head. This is a trip hazard. An irrigation system company should correct this issue.

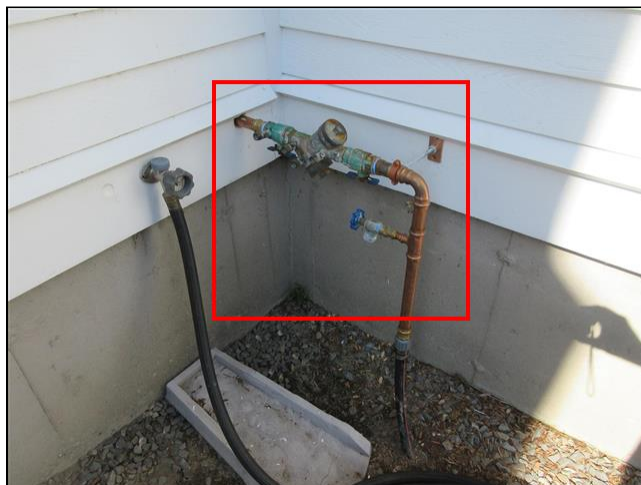
(2) There was irrigation system plumbing at the exterior of the house. It is important that an irrigation system company blow water out of the lines each fall before the ground freezes. The irrigation system was out of scope for this home inspection and was not inspected.

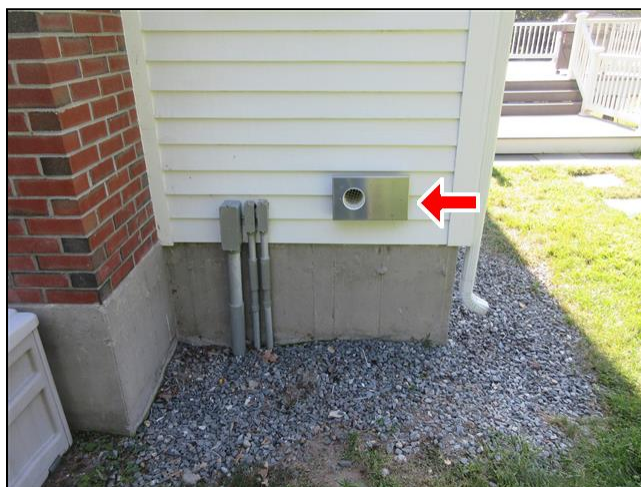
+ (3) There were intake and exhaust vents for the boiler at the exterior. These vents were close to the ground. If these vents become covered with snow or other debris exhaust gases can vent into the basement creating dangerous carbon monoxide conditions. This is a safety issue. These vents should be kept clear of snow and other debris at all times.

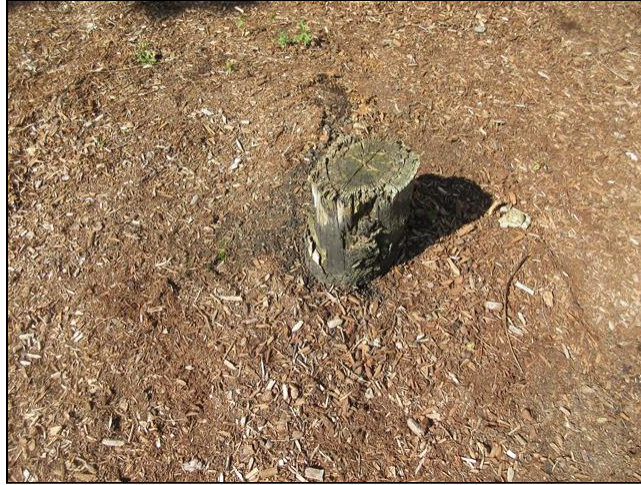
(4) There was a stump at the front of the house. This is a trip hazard. This stump should be removed.

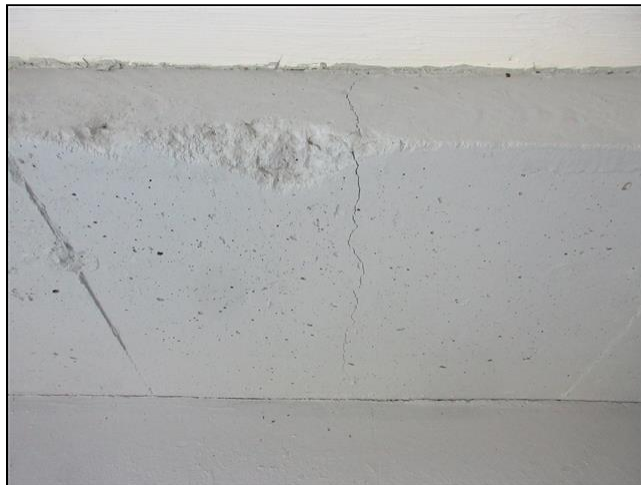
(2) There were cracks in the garage foundation. I recommend monitoring these cracks for further movement.

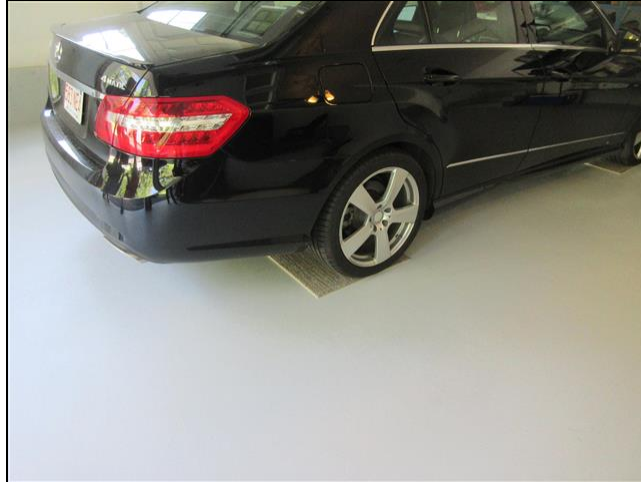
The garage floor was recently painted. If the floor was not painted with paint specifically designed for garage floors, the heat from car tires will cause the paint to peel. I recommend monitoring the garage floor for peeling paint.

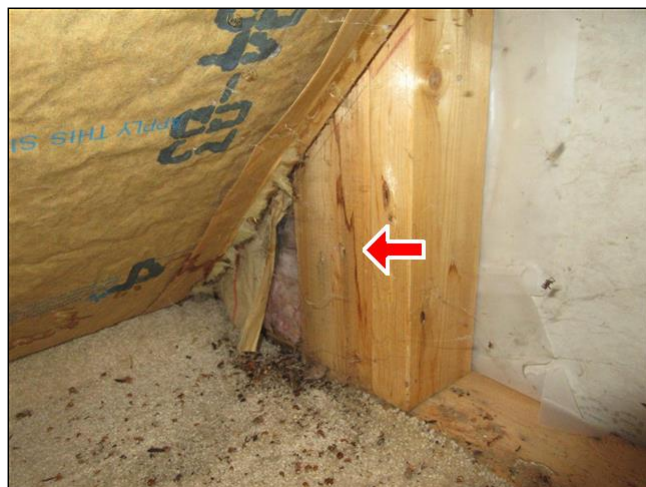
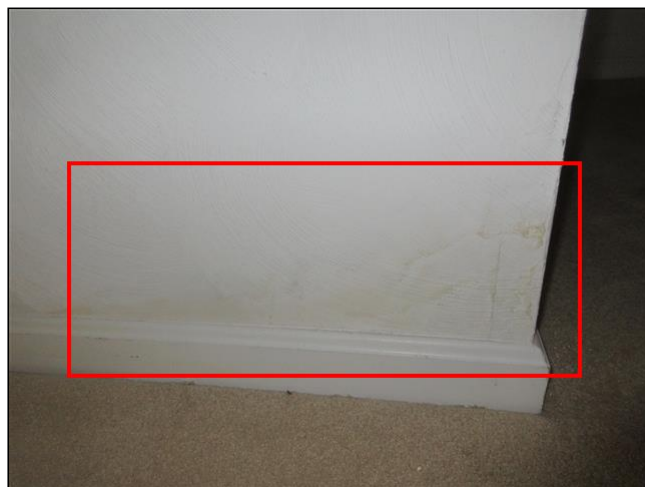
(1) There were water stains in the eaves space and on a wall at the right side of the second floor, likely caused by leaks from ice dams, see section 1.0 (2).

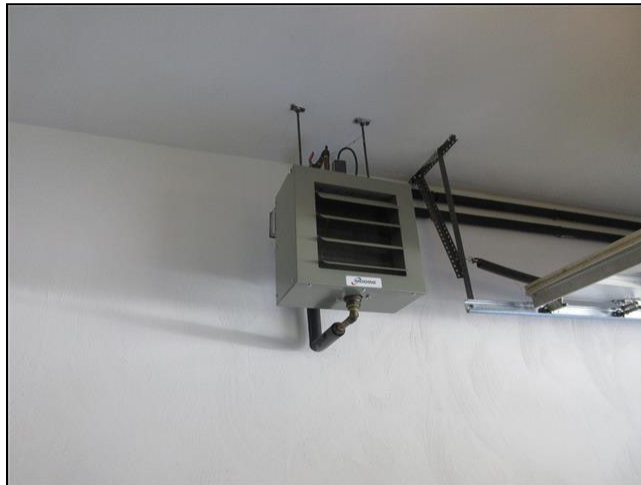
(1) There was a forced hot water heating zone in the garage. In the winter, when this zone is turned off, there is the potential for the pipes running to the heating unit to freeze and break. I recommend keeping the garage doors closed in winter. I recommend using this heating system to maintain sufficient heat in the garage to prevent freezing pipes.

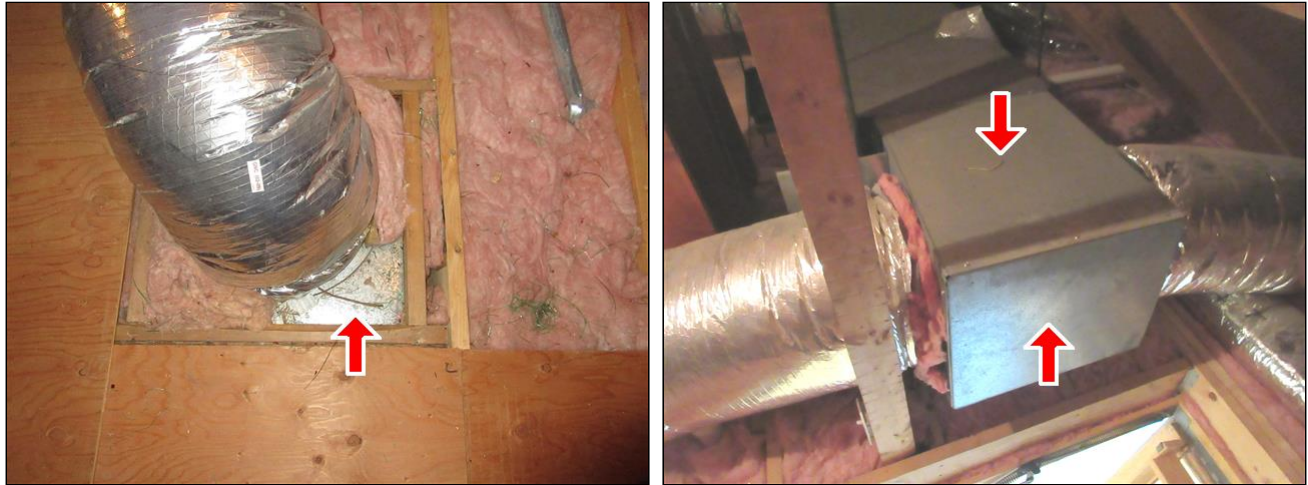
There was exposed HVAC ducting in the attic. This reduces the efficiency of the HVAC system. An HVAC technician should insulate these areas.

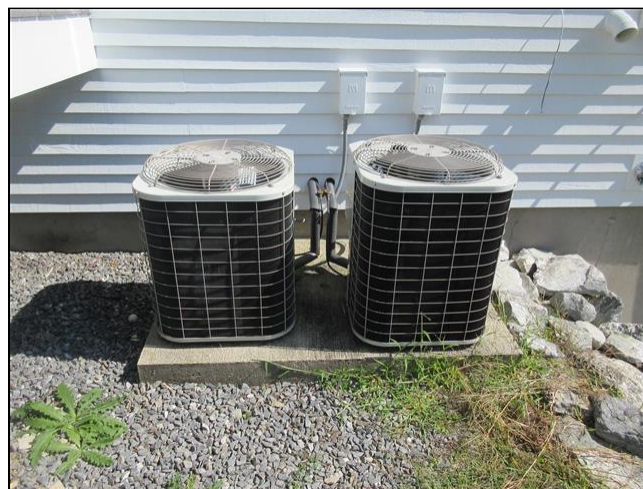
(1) The exterior AC compressor/condenser units were manufactured in June 2003 and March 2004. These units are approaching the end of their typical service lives. The Seasonal Energy Efficiency Rating, or SEER, has changed, requiring AC systems to be more efficient. When the exterior compressor condenser units are replaced the copper line sets and the interior AC coils will also have to be updated to keep in line with the new efficiency standards. This increases the scope and cost of the work. I recommend planning for replacement of these systems.

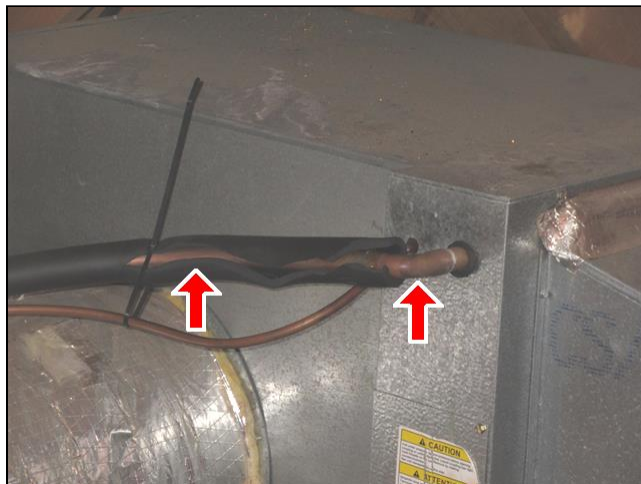
🔧 (3) There was missing insulation on the refrigerant lines in the attic. This will reduce the efficiency of the system and produce condensation. The refrigerant line insulation should be repaired or replaced by an HVAC technician.

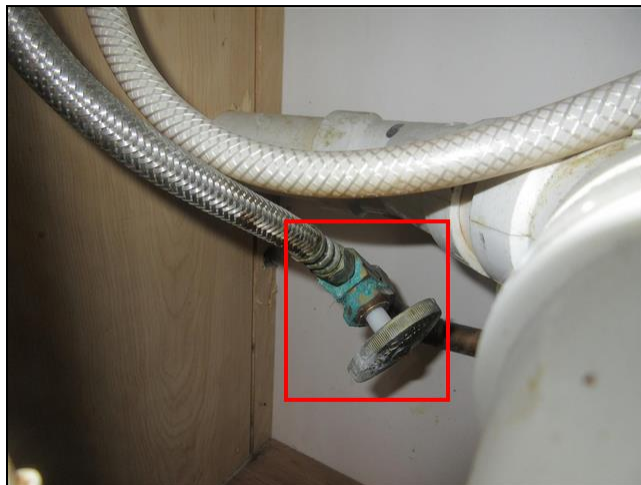
(1) There were corroded water supply pipes and valves under the sinks. There is the potential for leaks. I recommend monitoring these areas for leaks.

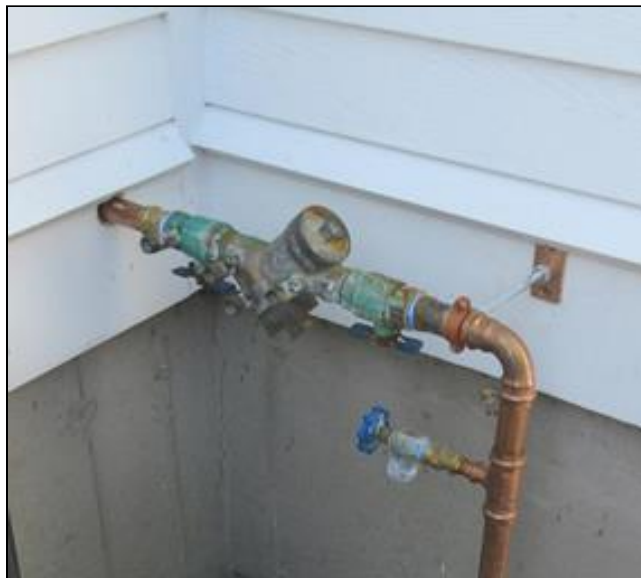
⚠ (1) There was a cross-connection at the irrigation system plumbing. A cross-connection is a condition that allows waste water to be siphoned back into the potable water system. At the irrigation system plumbing, there was no vacuum break to prevent water from the sprinkler heads from being siphoned back into the water supply pipes in the house, were the house to loose water pressure. Cross-connections in a plumbing system are a safety issue. A licensed plumber should remedy this problem.

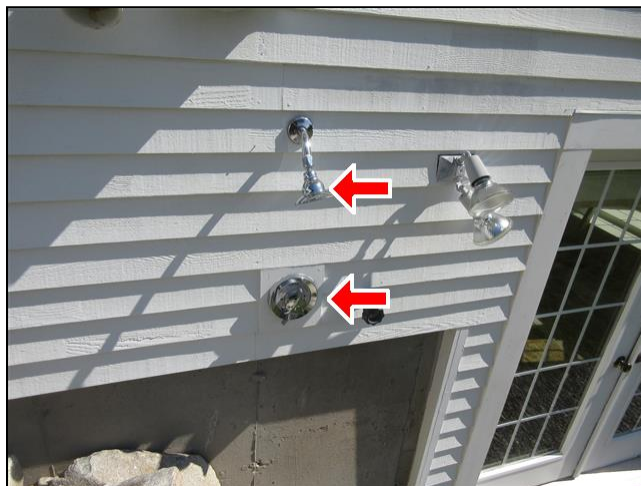
(2) It is important that every fall the water supplies to the outdoor shower are shut off in the basement and drained. This will prevent freezing and the potential of bursting pipes.

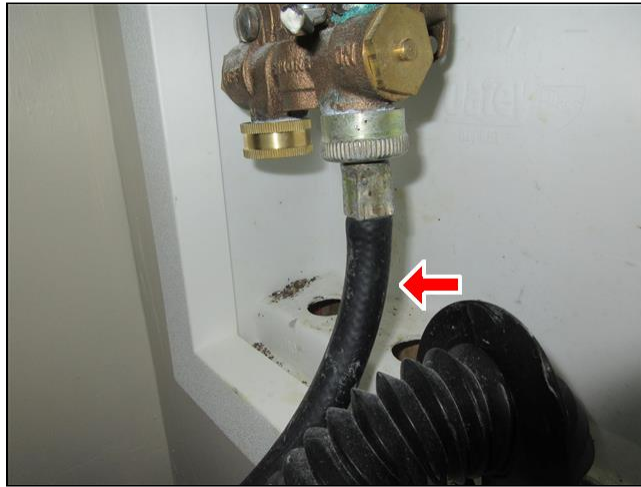
🔧 (3) A rubber line supplied water to the washing machine (no hot water was connected). These lines are not rated to remain under constant pressure. Many people do not turn off the valve between loads of laundry. To prevent a burst hose and flooding, this line should be upgraded to a braided stainless steel line.

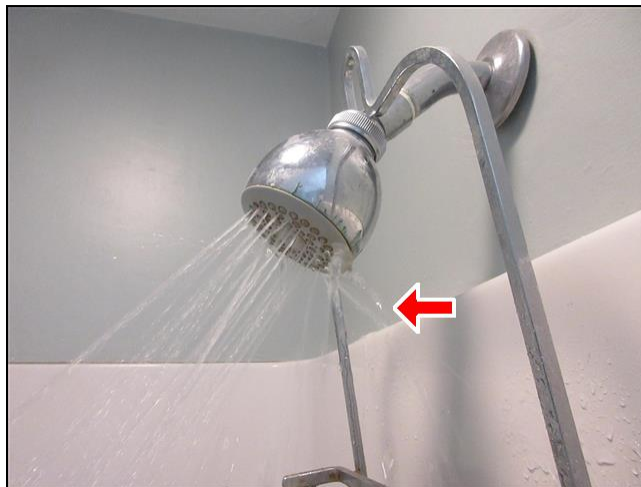
🔧 (5) The shower head in the master bathroom sprayed water on the wall. A licensed plumber should repair or replace this shower head.

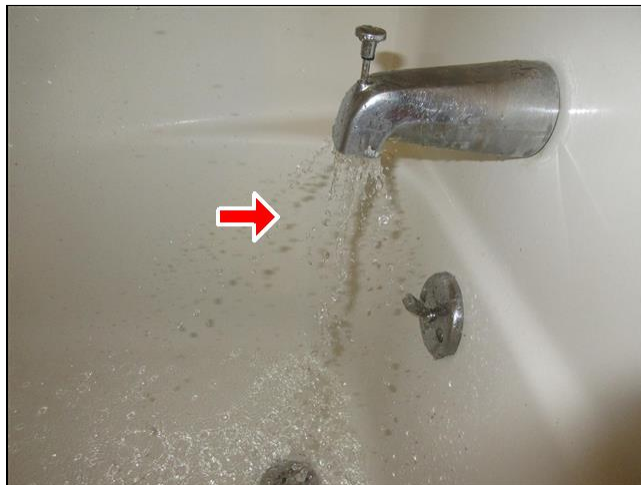
🔧 (6) The mechanism that diverts water from the tub faucet to the shower head in the second floor hall bathroom was not functioning properly. Water ran out of both the shower head and the tub faucet, reducing water pressure at the shower head and wasting water at the tub faucet. A licensed plumber should repair or replace this plumbing.

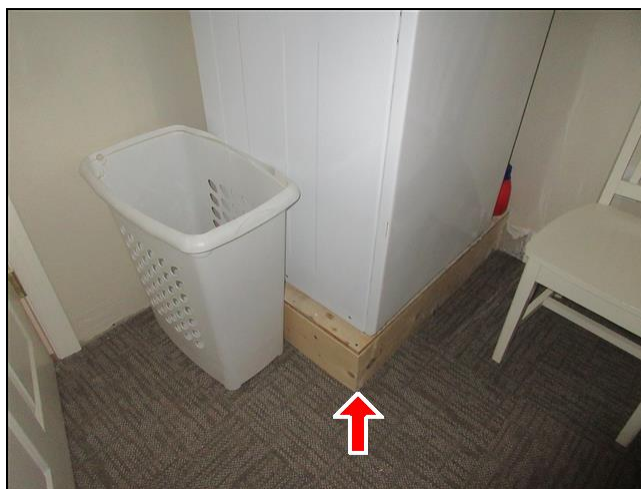
(1) There was a sewage ejector pump located under the washing machine. This pump was not readily accessible and was not inspected.

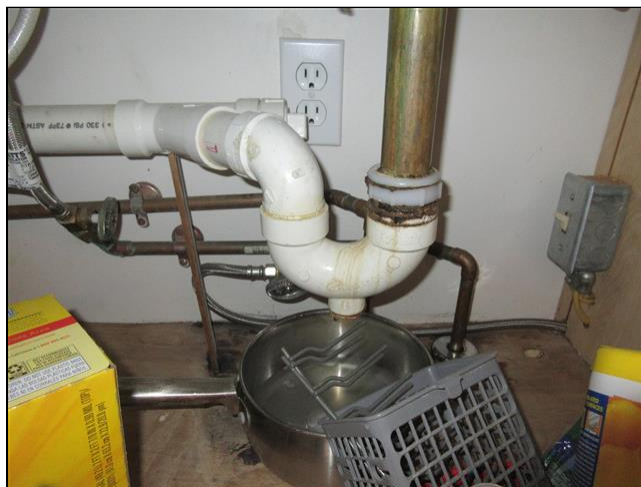
🔧 (2) The drain under the kitchen sink was leaking. I recommend repair by a licensed plumber.

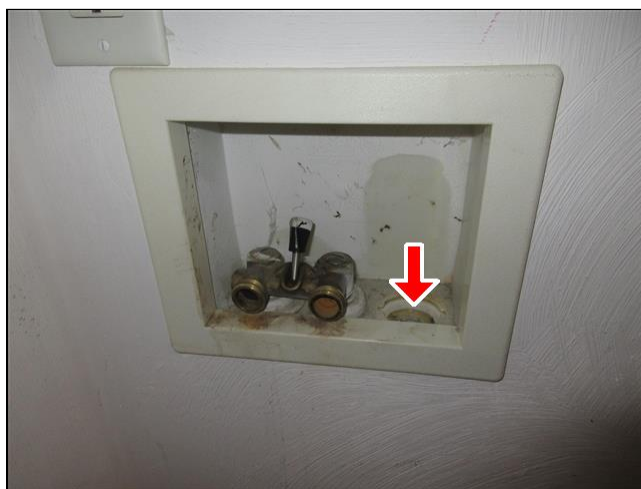
⚠️ (3) There was a trap located in the unused first floor laundry closet for the washing machine drain. There was no washing machine hooked up to this drain. If the drain is left unused there is a potential for the water in the trap to evaporate and then sewer gasses may enter the house. This is an unsanitary condition. A washing machine should be hooked up to this drain or the drain properly capped off. If the basement washing machine is removed, the basement drain should be capped off.

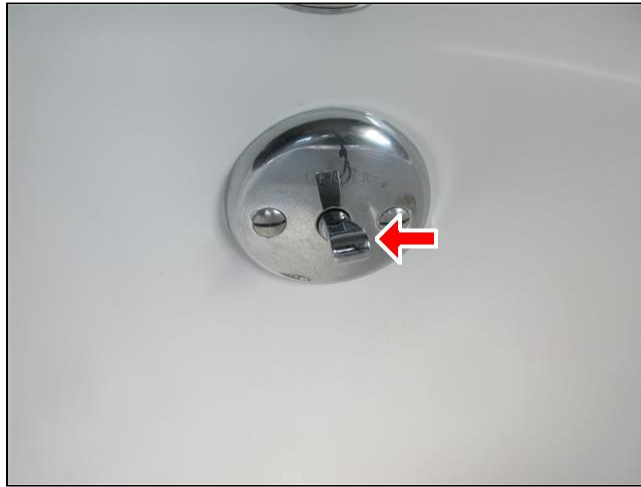
🔧 (4) The drain stopper control did not fully seat a drain stopper in a closed position in the whirlpool tub. Water drained out of the tub with the drain stopper engaged. The drain stopper control lever was stiff and difficult to operate. I recommend repair by a licensed plumber.

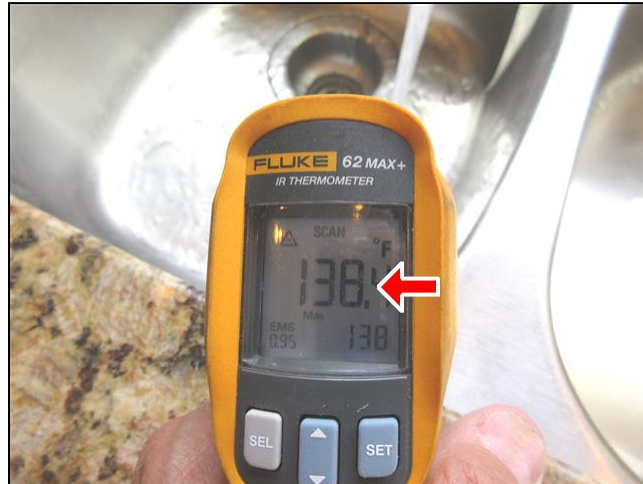
+ The hot water was set to 138 degrees Fahrenheit. This is a safety hazard, especially when small children are present. I recommend that the hot water be set to 120 degrees Fahrenheit.

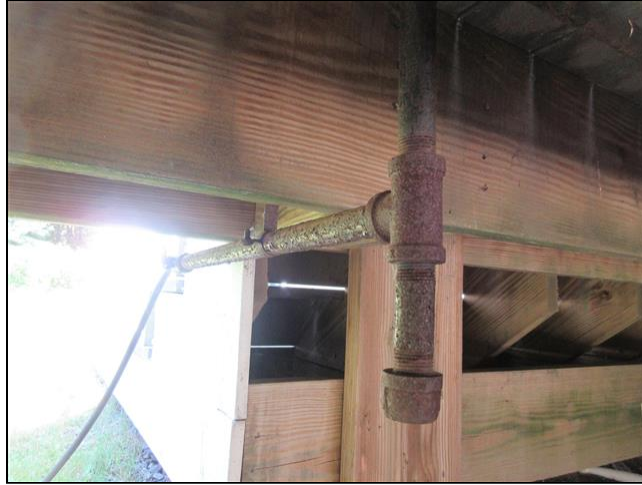
+ The gas pipe for the gas grill was rusted. A licensed plumber should check this pipe and replace if needed.

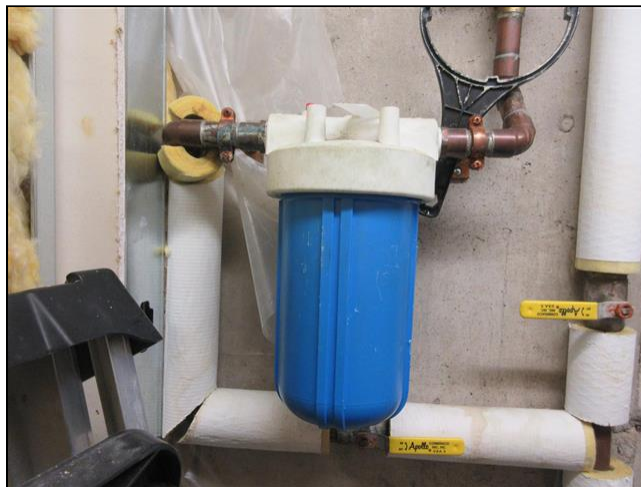
(2) There was a whole house sediment filter. When the filter is replaced, a replacement O ring should be on hand in case the existing O ring gets damaged when the filter housing is removed. A small amount of bleach should be added to the filter housing when the new filter is installed to kill any bacteria introduced into the water piping. The filter should be thoroughly flushed by running water at an outdoor faucet or any sink inside the house. This is for your information.

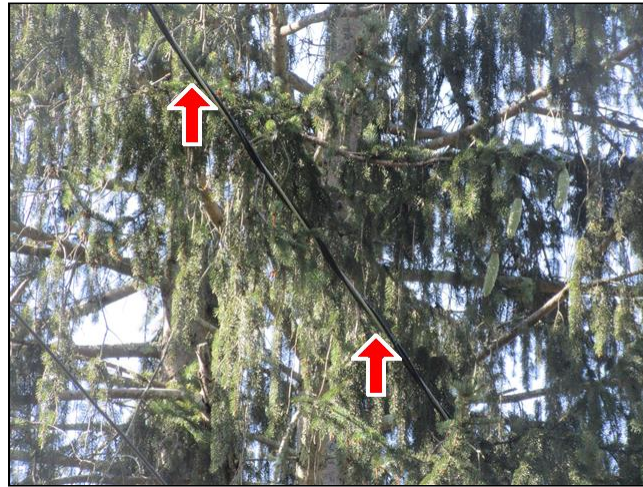
+ The service entrance cables ran through trees en route to the house. There were tree branches rubbing against the cables. There is the potential for the insulation on the cables to wear through and the electrical service to short circuit. The electric company should prune the branches away from the service entrance cables.

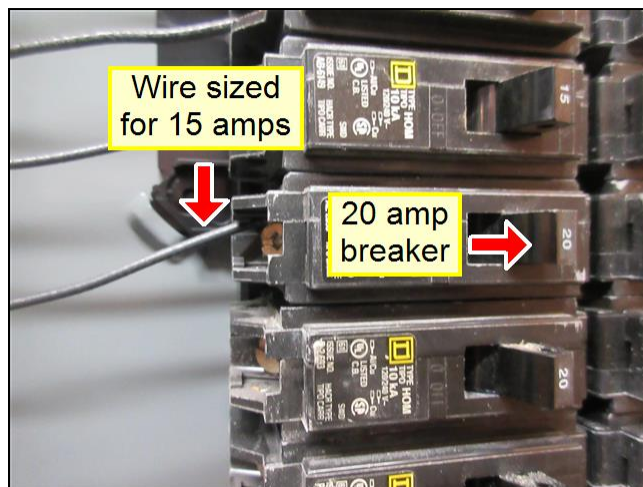
+ (1) There was an over-fused circuit in the smaller sub panel. An over-fused circuit is a circuit that has a breaker sized larger than the wire that it serves. A 20 amp breaker served a wire sized for 15 amps. When a circuit is over-fused, the branch circuit wires can heat up and cause a fire. A licensed electrician should correct this issue.

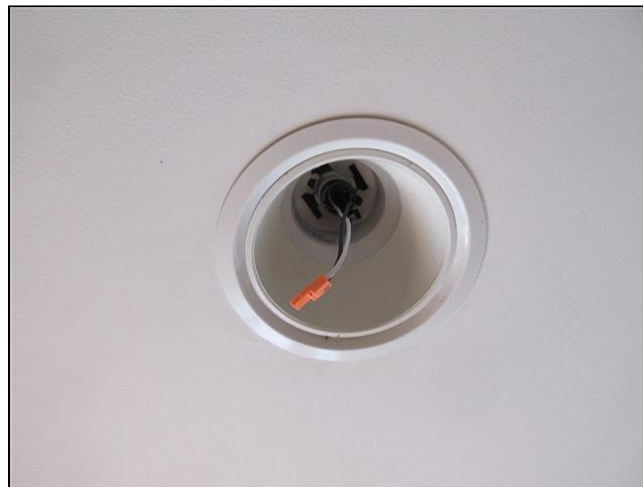
🔧 (1) There was a damaged recessed light in the kitchen. A licensed electrician should repair or replace this fixture.

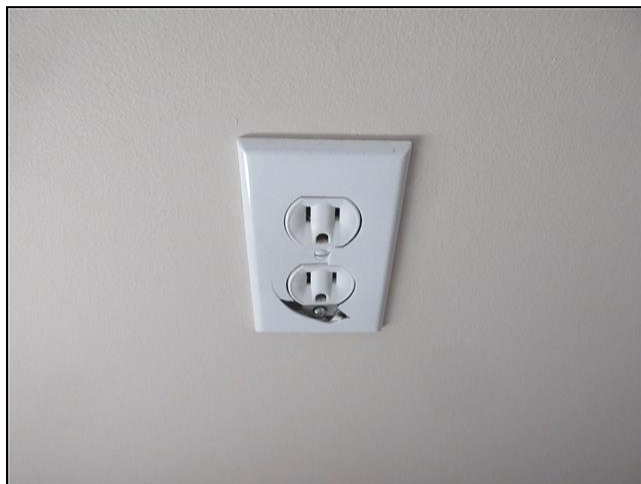
⊕ (2) There were broken cover plates next to the basement sink and in the back right bedroom. A licensed electrician should replace these cover plates.

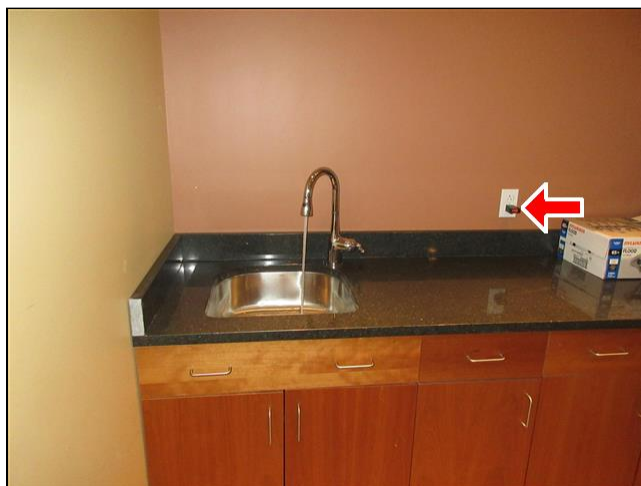
⊕ The electric receptacle next to the basement sink was not GFCI. All receptacles within 6 feet of water, in unfinished areas of the basement, and at the exterior of the house should be equipped with ground fault circuit interrupters (GFCI). GFCI's detect the amperage flow going in and out of the receptacle. If this flow varies by as little as .005 amps, the receptacle will trip. These receptacles should be tested on a regular basis. I recommend that a licensed electrician install GFCI's where needed.

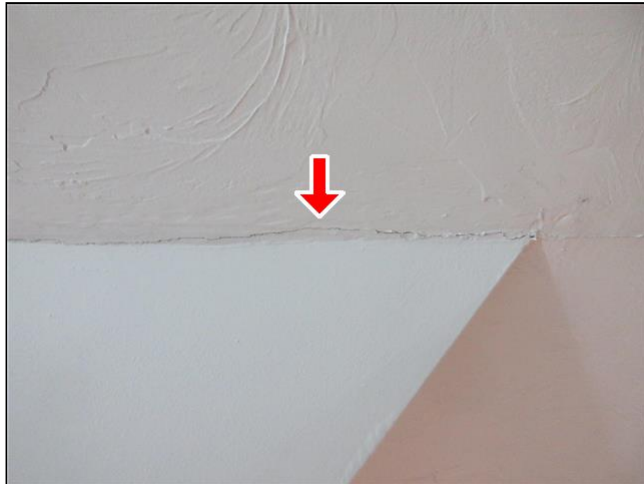
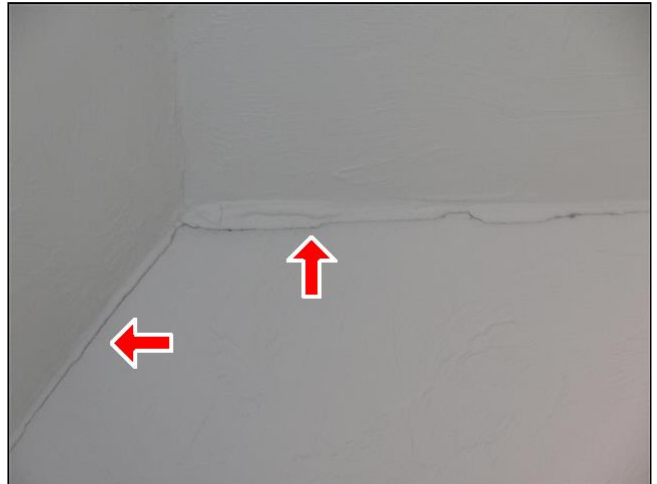
(1) There were cracks in the walls and ceilings. A qualified painter should repair these cracks and the cracks monitored for further movement.

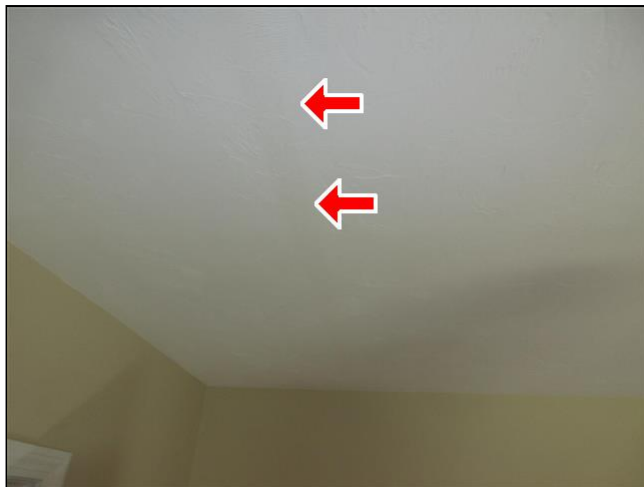
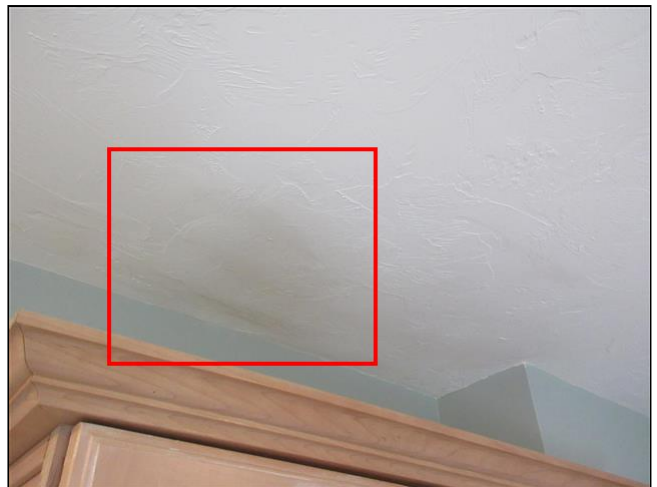
(2) There were water stains on the ceilings in the back right bedroom and in the master bathroom, likely caused by leaks from ice dams, see section 1.0 (2).

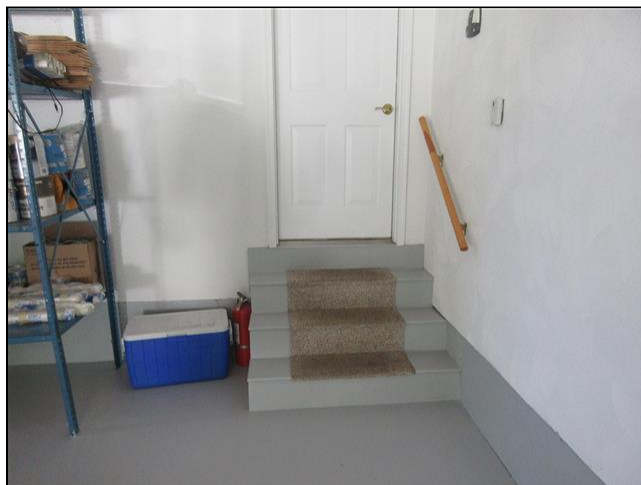
⚠ (1) There was no landing in front of the door between the garage and the house. A person leaving the house could trip when starting down the stairs. These stairs are a trip hazard. I recommend that a landing be installed.

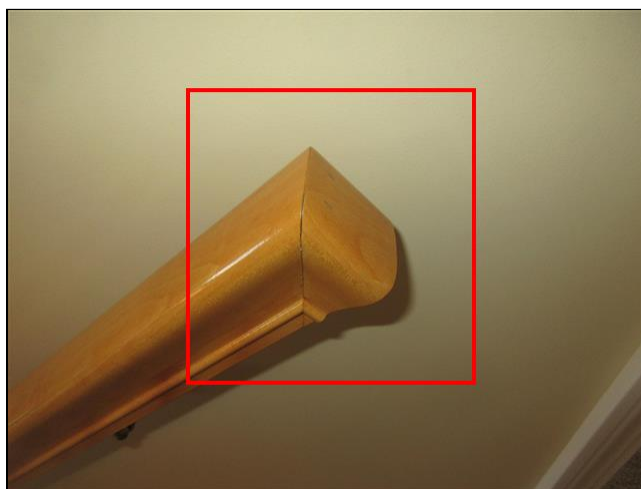
⚠ (2) There was no railing return at the second floor stairs. All railings should return back to the wall to avoid a trip hazard should someone get their clothing caught on the end of the railing. This railing should be repaired or replaced.

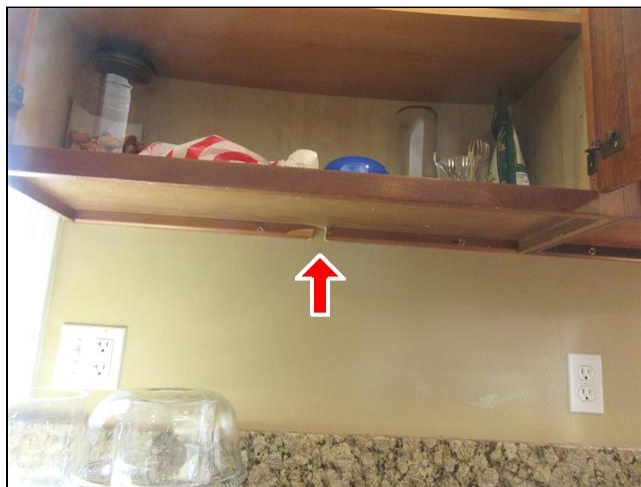
⚠ (1) At the cabinet next to the kitchen sink, a notch had been cut in the wood strip that supports the back of the cabinet. Two of the screws had been removed. This cabinet is not properly supported. This is a safety hazard. A qualified contractor should repair this cabinet.

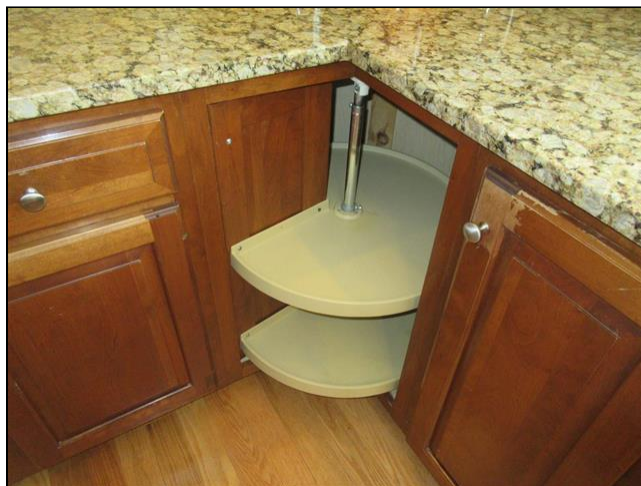
🔧 (2) The rotating cabinet (lazy susan) in the kitchen did not spin freely. A qualified contractor should repair this cabinet.

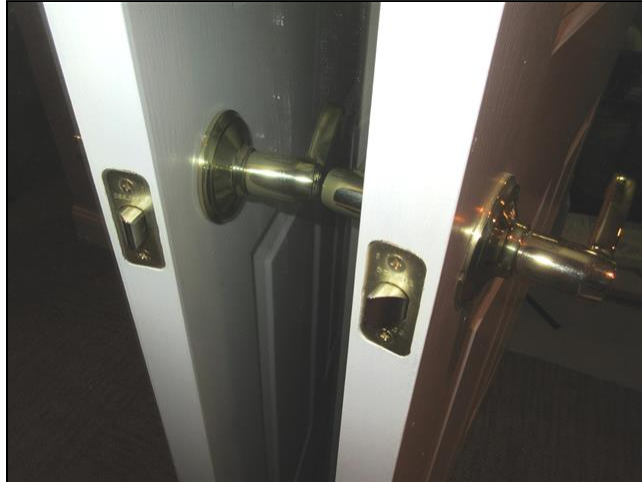
⚠ (1) The door handle at the door to the closet next to the basement bathroom made contact with a mirror. This is a safety hazard. A door stop should be installed.

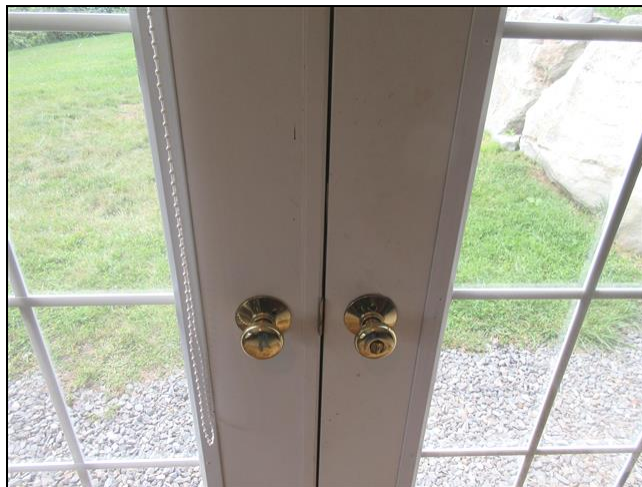
⚠ (2) There was no deadbolt at the basement french doors. This is a security issue. A qualified carpenter or locksmith should install a deadbolt.

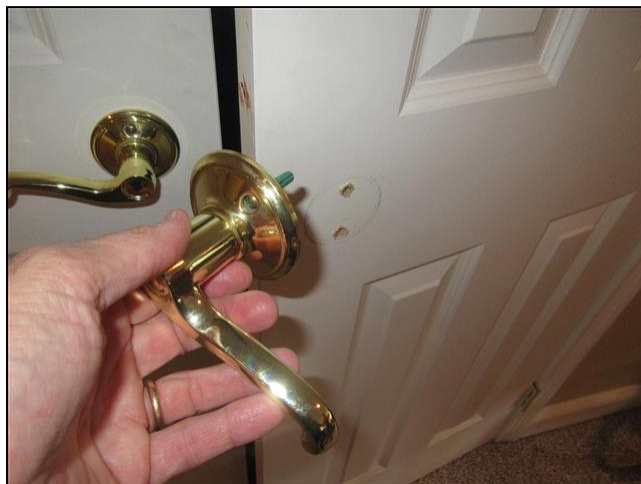
🔧 (3) One of the handles to the closet where the electric panels are located was loose. A qualified contractor should repair this door.

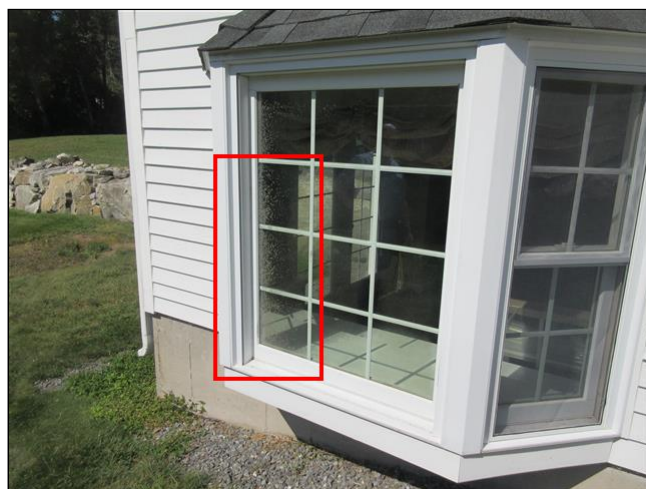
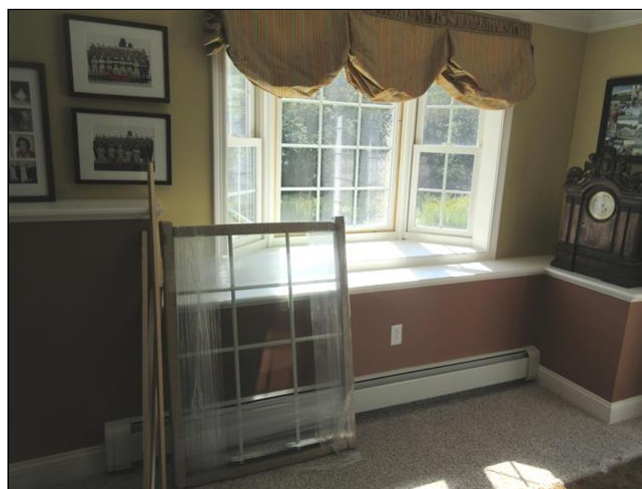
🔧 The insulated double paned window in the basement had broken seals. Moisture gets between the two panes of glass and fogs the window. A new window was leaning against the wall in the basement. I recommend that this new window be installed.

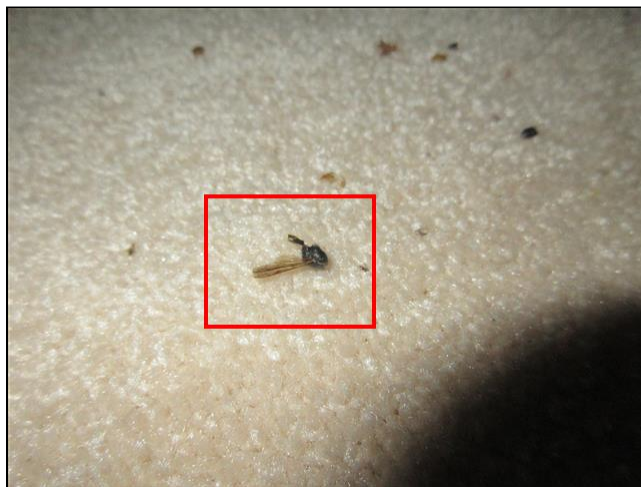
🐜 (1) In the eaves space at the right side of the second floor, there was an ant piece with a wing attached. This indicates that carpenter ants have been nesting in the house. There is the potential for concealed damage. I recommend that a pest control company treat the house for ants on an annual basis.
