Inspection Report

123 Main Street
Anytown MA

Still River Home Inspections, Inc.

| Date: 10/23/2017 | Time: 09:00 AM - 12:00 PM | Report ID: 082817 sample |

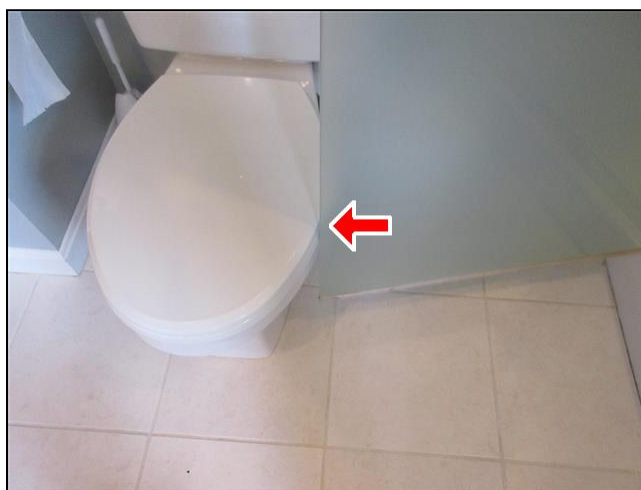
🚑 (3) The glass shower door at the master bathroom shower made contact with the toilet. This is a safety hazard. I recommend repair by a qualified contractor.

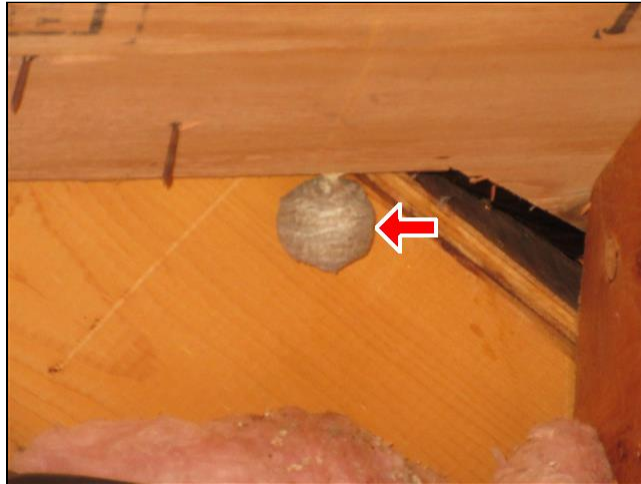
+ (4) There were wasp nests in the attic. A pest control company should treat for wasps.

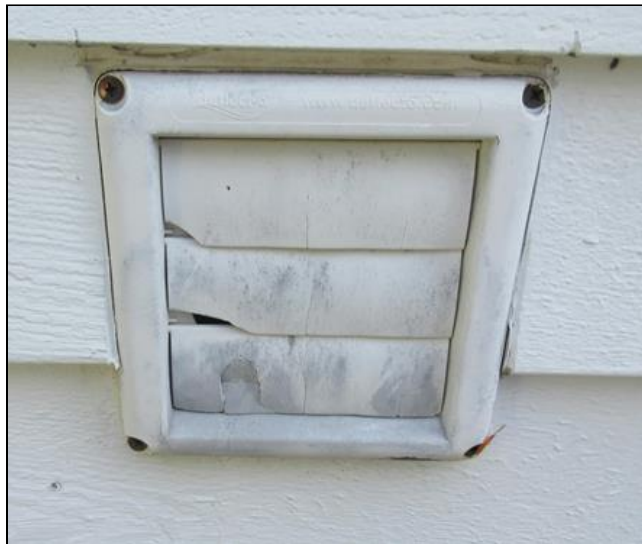
🔧 (1) There was a damaged vent hood at the back of the house. This vent hood should be replaced.
