# Inspection Report

123 Main Street  
Anytown MA

**Still River Home Inspections, Inc.**

| Date: 9/7/2017 | Time: 09:00 AM - 12:30 PM | Report ID: 030717 sample |

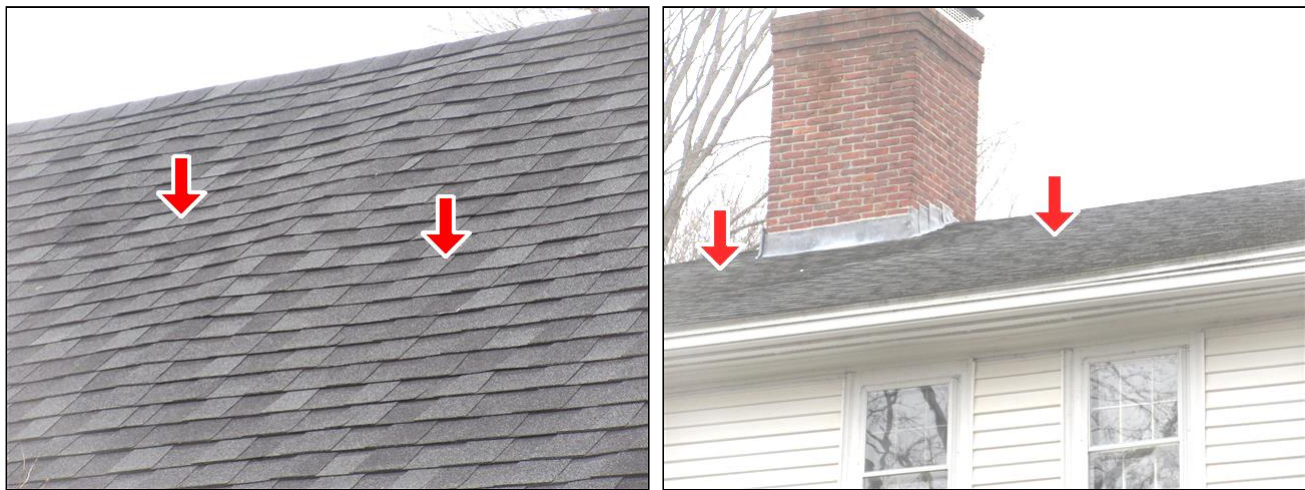
(2) Areas of the roof were bowed inwards, see section 3.7 regarding issues with the structure in the attic.

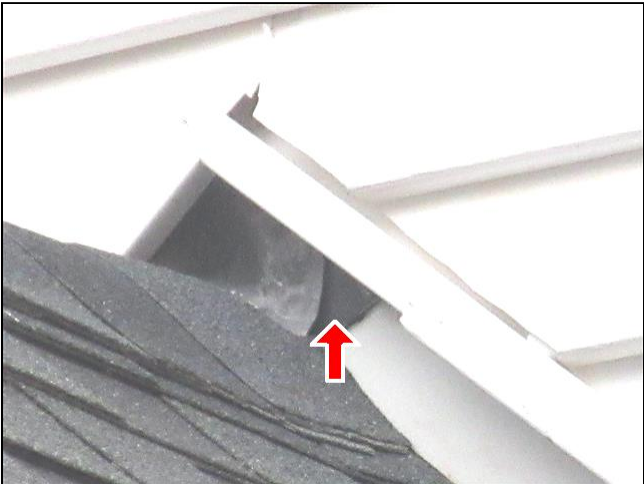
There was a gap in the flashing between the former carriage house roof and the side wall of the main house. A qualified contractor should install additional flashing at this location.

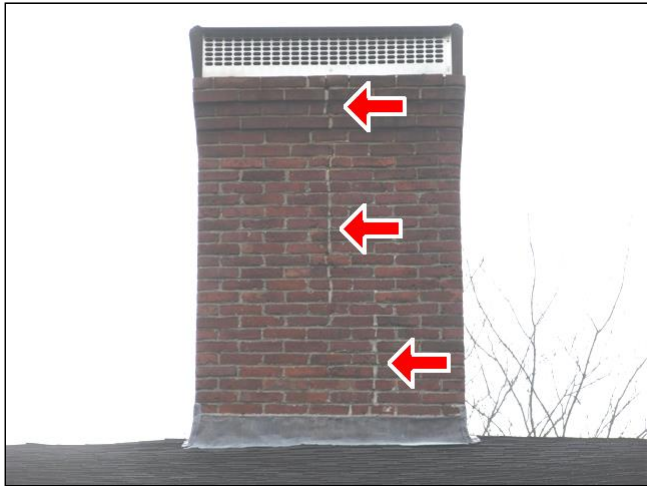
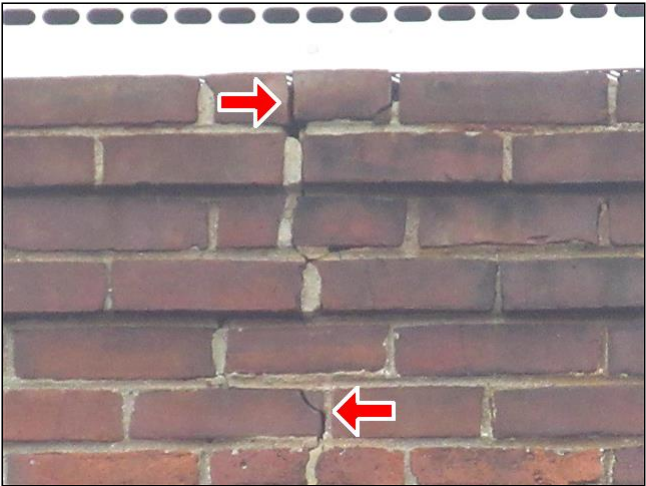
There were cracks in the chimney, some of which had been repaired. I recommend further inspection of the chimney by a qualified chimney sweep and repairs as needed.

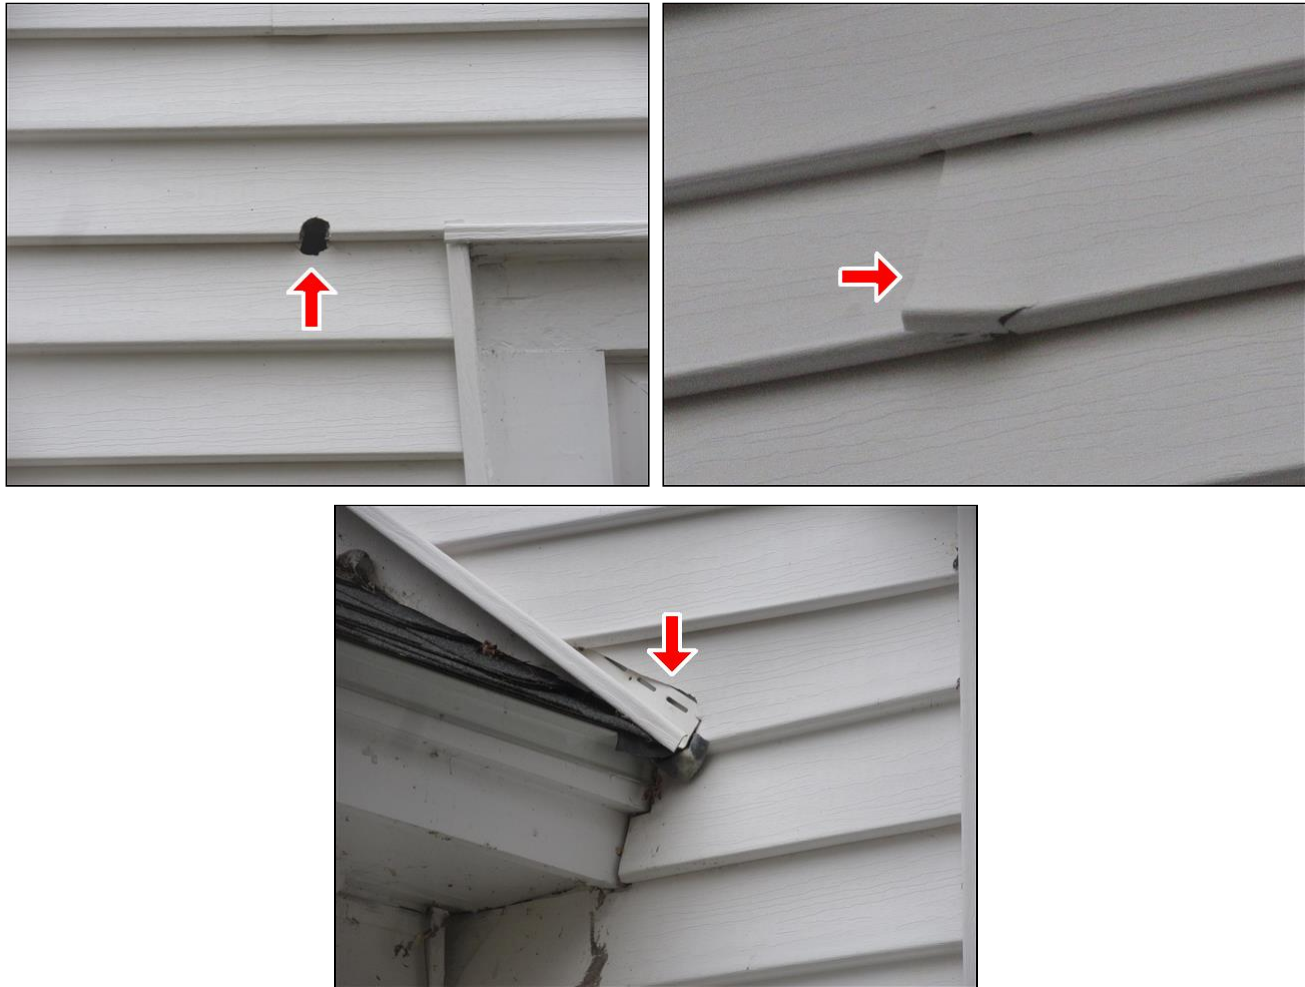
🔧 (1) There were places on the house where the siding was loose or damaged. There is the potential for water to penetrate these areas and damage the structure underneath. A vinyl siding contractor should repair these areas.

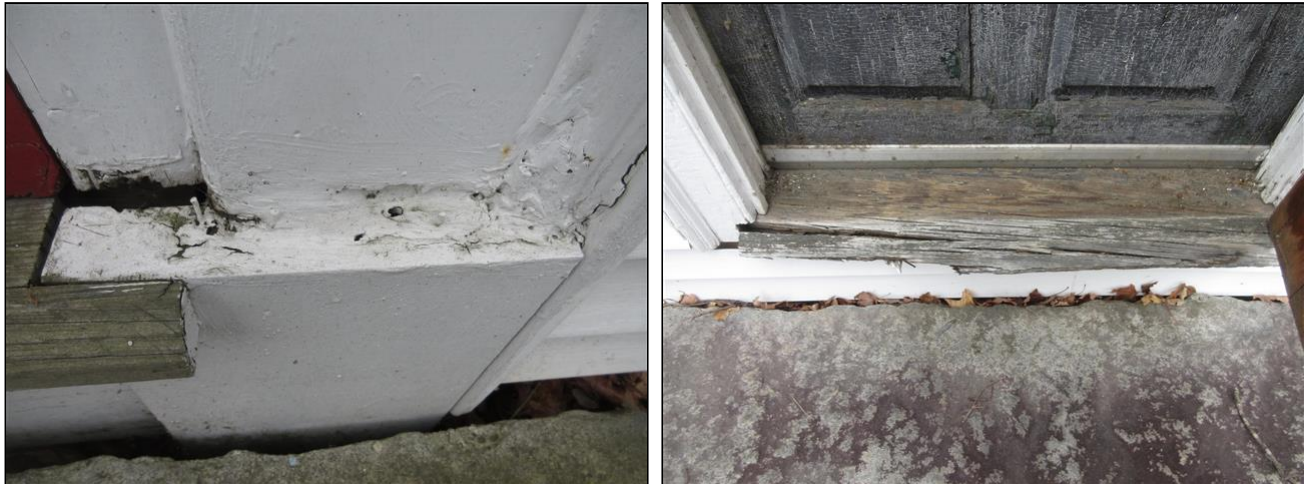
(2) There was decayed trim at the front door and a decayed door sill at the door at the right side of the house. A qualified carpenter should repair these areas.

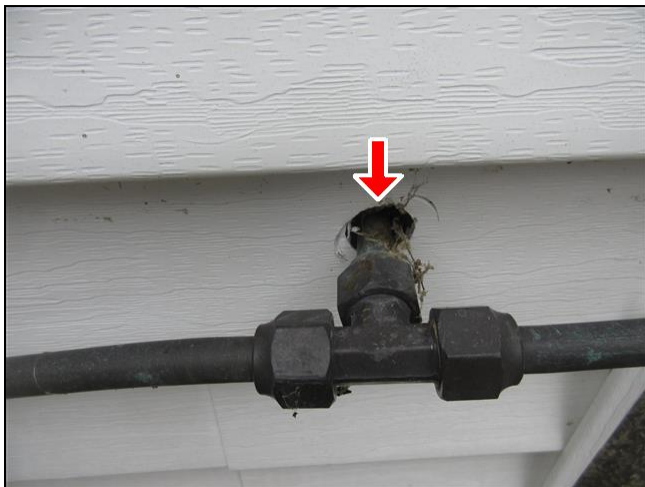
(3) There was a gap around the gas line where it ran into the house. This gap will reduce the energy efficiency of the house and may enable pests to enter the house. The gap should be properly sealed.

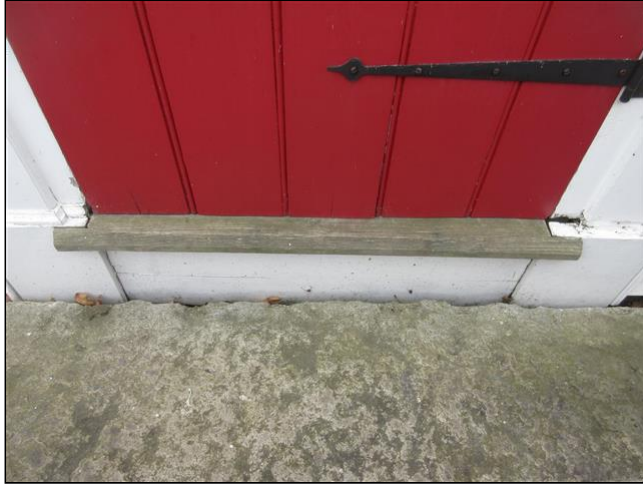
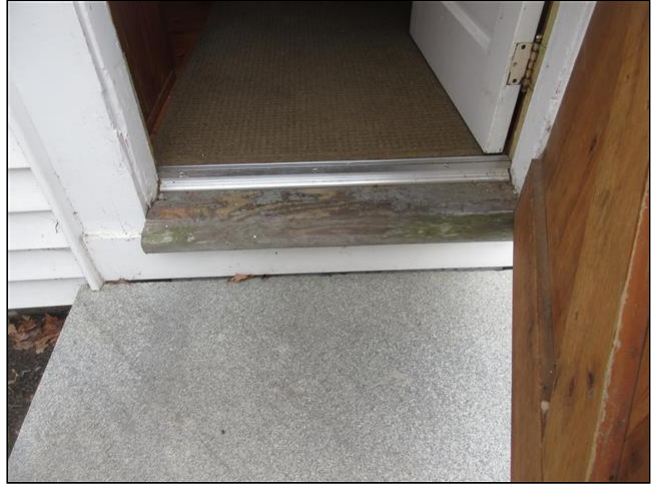
- 🔧 (1) The door sills were bare wood. These sills should be painted, stained, or treated with linseed oil.

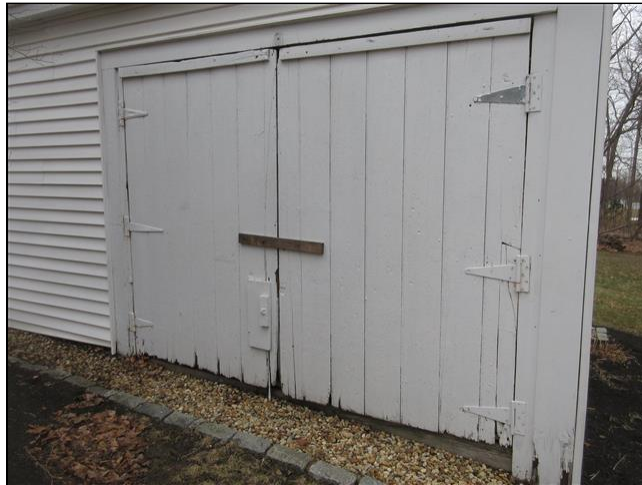
- 🔧 (2) The doors to the back unheated area of the former carriage house were decayed and in poor condition. These doors should be replaced.

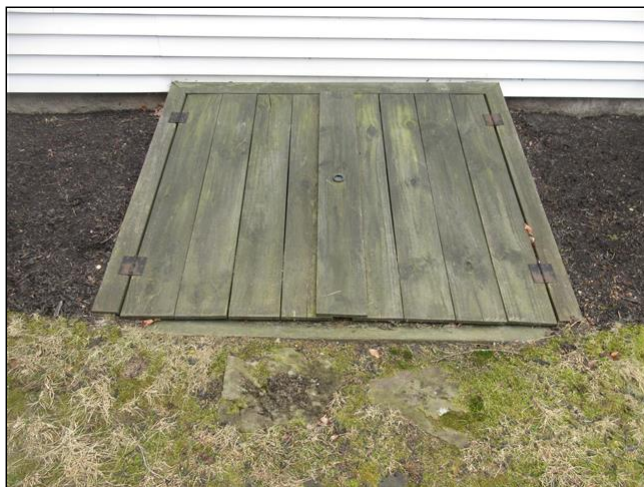
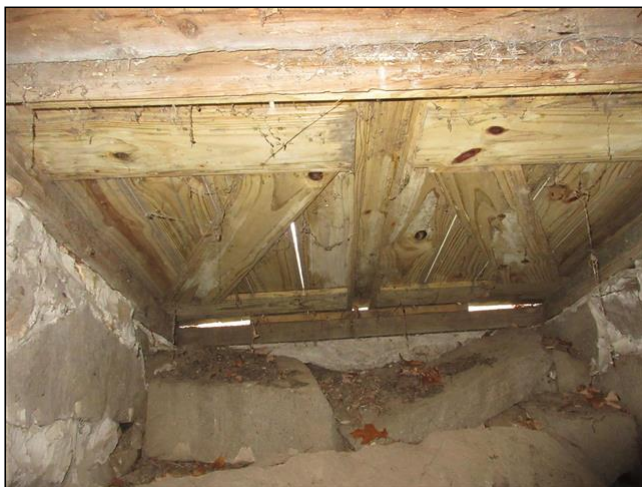
🔧 (3) The wood bulkhead doors were in contact with the ground. There is the potential for decay and wood destroying insect infiltration. There were gaps between the boards in the doors, which will allow water to seep down into the basement. I recommend that a qualified contractor repair or replace the doors.

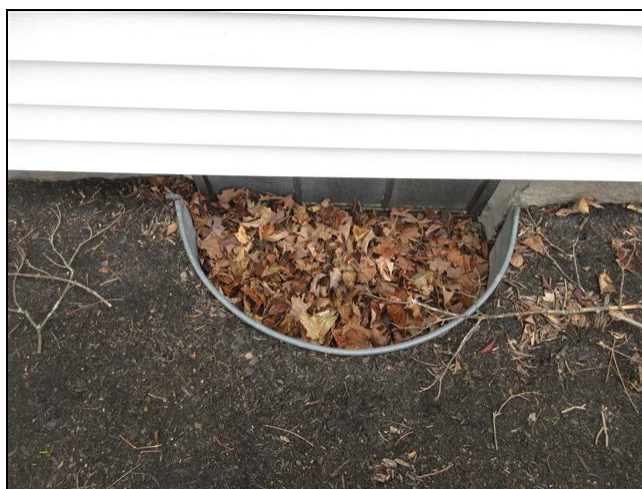
🔧 (2) The window wells at the basement windows were filled with debris. There is the potential for deterioration in the window frames due to prolonged exposure to moisture. The window wells should be cleaned out and kept clear of all debris.

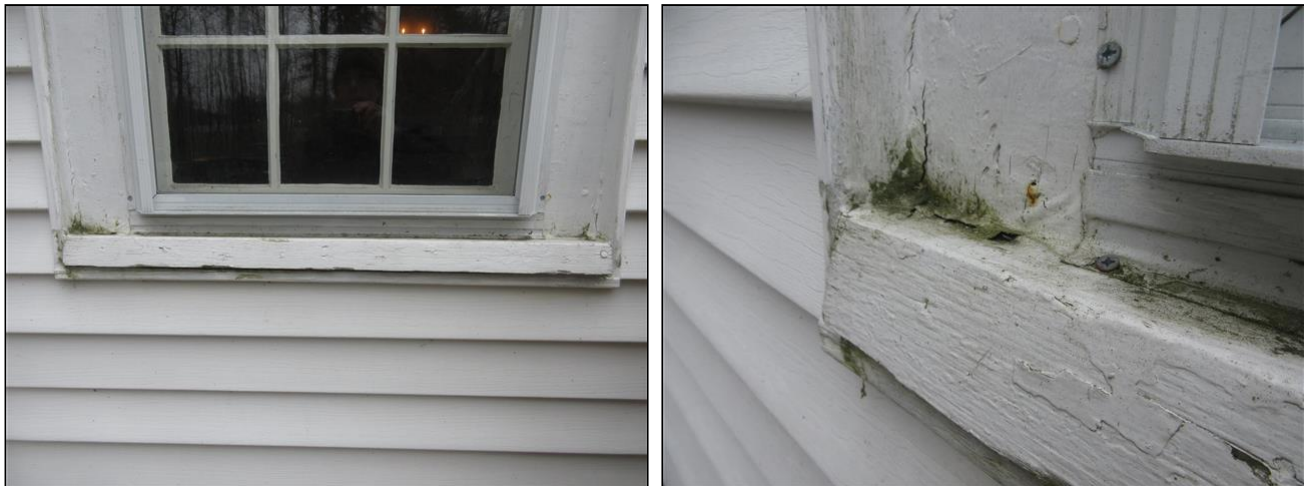
🔧 (3) A window sill at the left side of the house sloped towards the house. There was decay in the trim. A qualified carpenter should correct this issue.

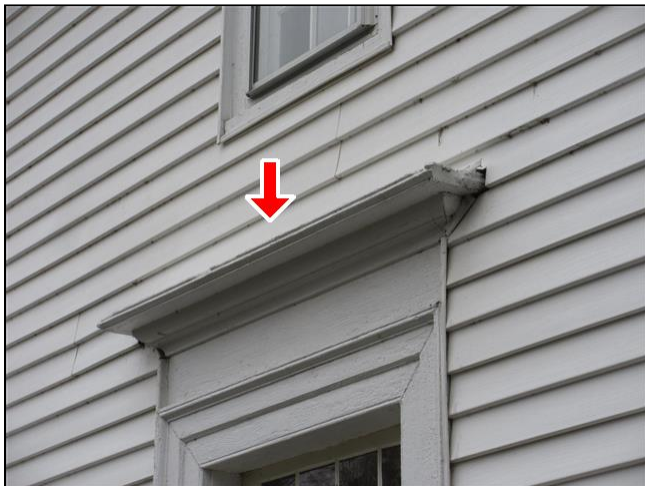
🔧 There was no flashing over the wood trim above the front door. There is the potential for water intrusion and decay. A qualified carpenter should install flashing in this area.

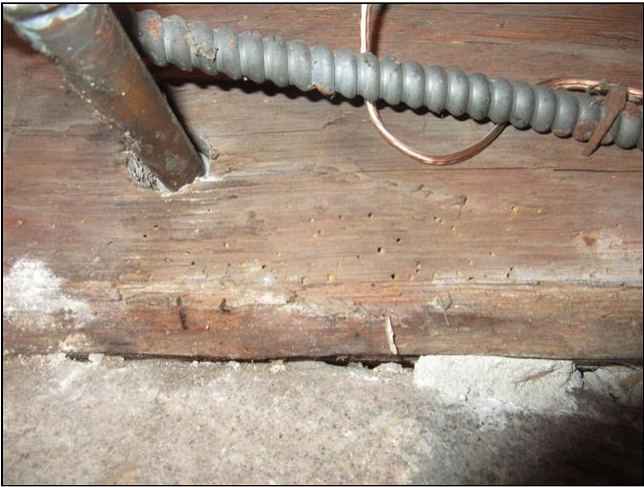
(3) There was wood boring beetle damage in the basement structure. I recommend running a dehumidifier in the basement to reduce the humidity level and reduce the chance of further beetle damage.

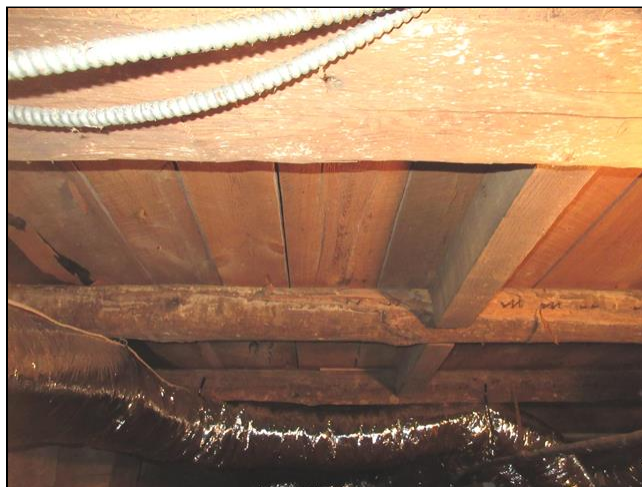
🔧 (1) Some of the beams and joists in the basement were undersized and/or widely spaced. Some of the floors in the house were sloped and some bounced when walking on them. I recommend that a qualified contractor with experience repairing post and beam structure make repairs as needed.

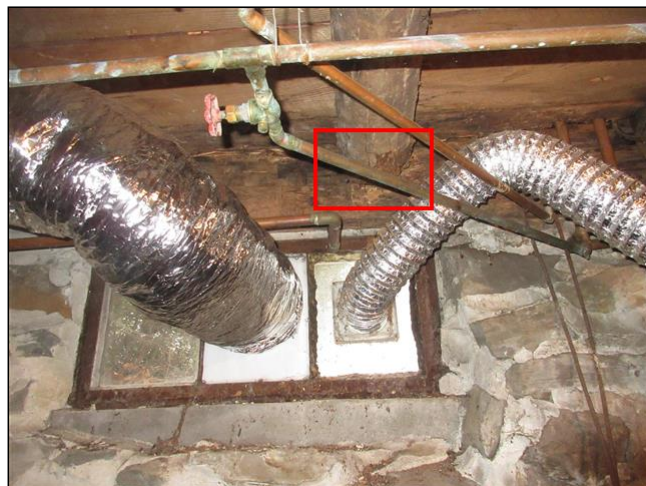
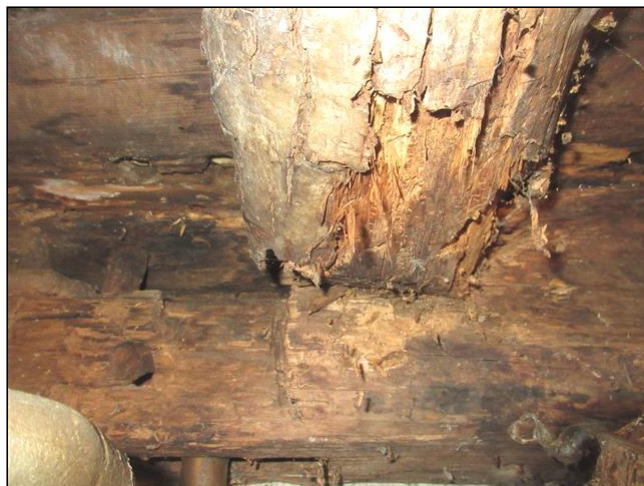
🔧 (2) The end of one of the joists in the basement was decayed. This joist should be repaired or replaced by a qualified contractor.

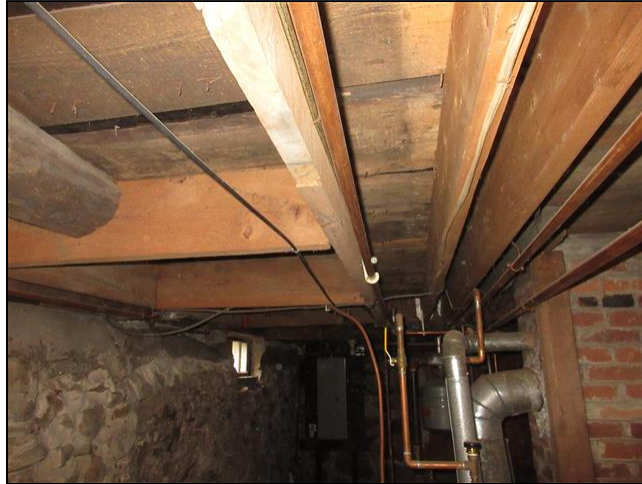
(3) There joists in the basement ceiling had been replaced at the front of the basement. This is for your information.

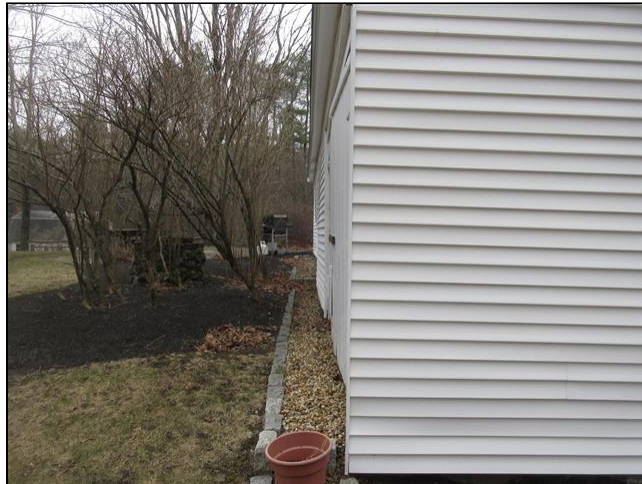
(1) The former carriage house walls were not straight and true. I recommend monitoring these walls for further movement.

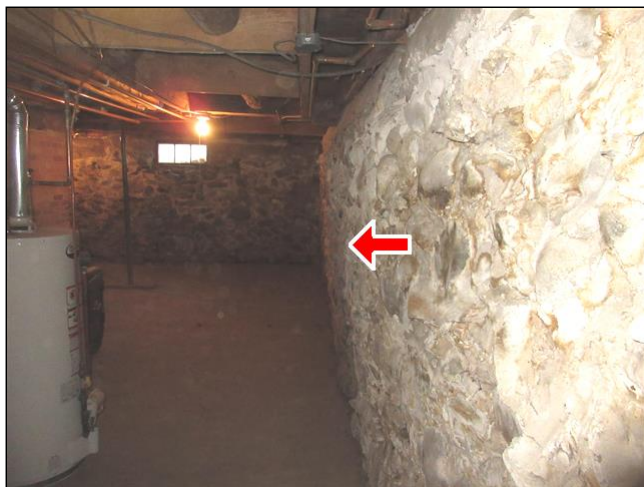
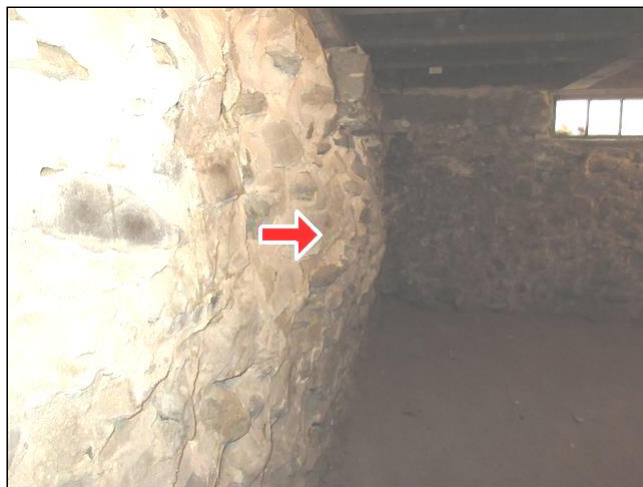
🔧 (2) Areas of the basement walls were significantly bowed inwards. I recommend further inspection by a structural engineer. I recommend that a qualified contractor make repairs as needed in accordance with the structural engineer's recommendations.

(2) Areas of the basement walls were significantly bowed inwards. I recommend further inspection by a structural engineer. I recommend that a qualified contractor make repairs as needed in accordance with the structural engineer's recommendations.

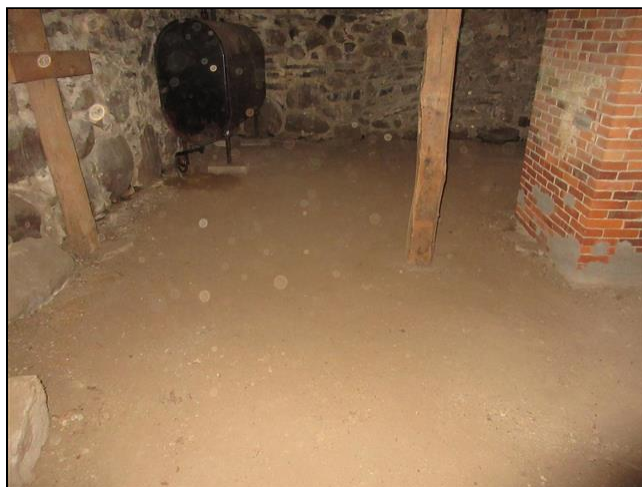
🔧 Most of the basement floor was dirt. Dirt floors can lead to moisture problems including mold, mildew, rot and wood destroying insects, and can contribute to high levels of radon. I recommend that a concrete floor be poured in the basement.

Most of the basement floor was dirt. Dirt floors can lead to moisture problems including mold, mildew, rot and wood destroying insects, and can contribute to high levels of radon. I recommend that a concrete floor be poured in the basement.

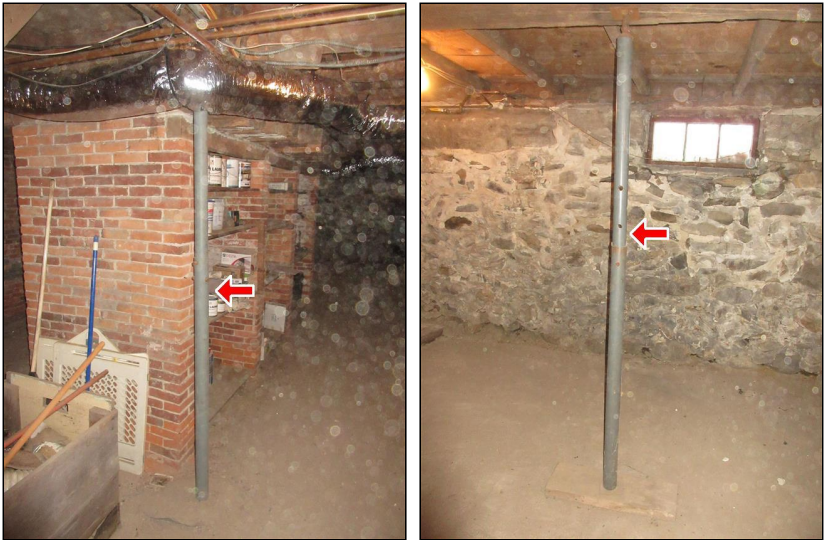
🔧 There were screw jacks used as permanent columns in the basement. Screw jacks are temporary fixtures and should be replaced with lally columns with appropriate footings. I recommend that a licensed contractor make these repairs.

There were screw jacks used as permanent columns in the basement. Screw jacks are temporary fixtures and should be replaced with lally columns with appropriate footings. I recommend that a licensed contractor make these repairs.

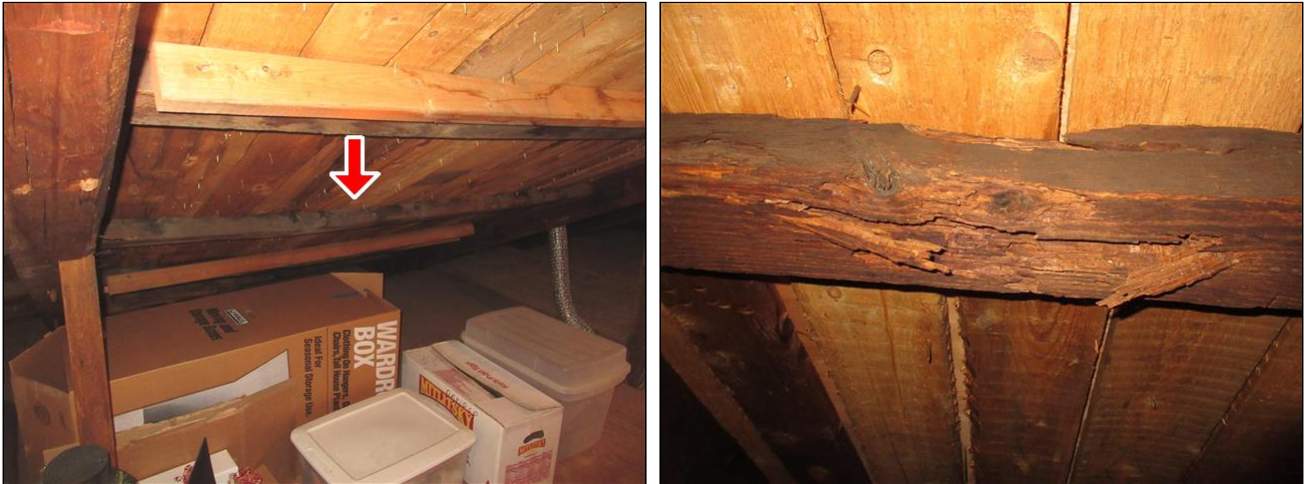
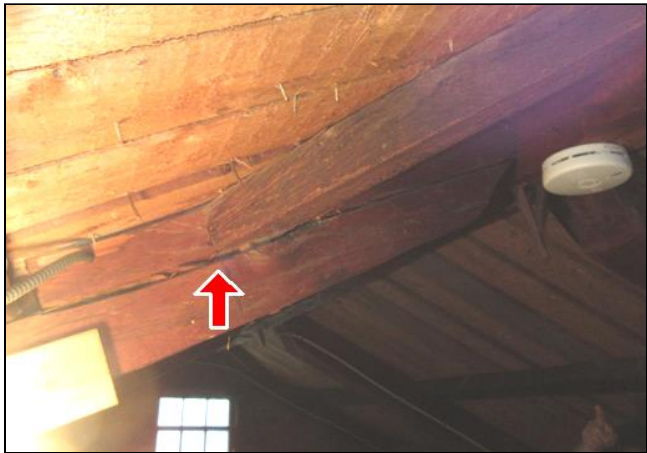
🔧 (1) Some of the purlins between beams in the attic were bowed downwards, creating sagging areas of the roof visible from the exterior. Some of the purlins were decayed and some had been repaired with 2x4's nailed to them. There were checks (common cracks that occur in beams) in the beams supporting the roof that were larger than usual. I recommend that a qualified contractor with experience repairing post and beam structure make repairs as needed.

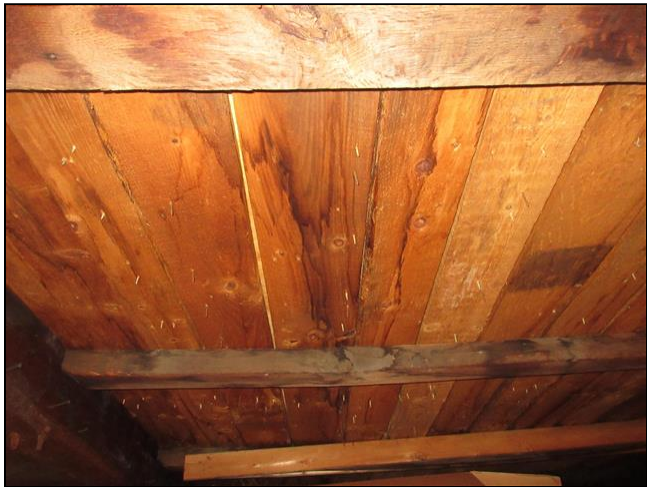
(2) There were water stains on the underside of the roof sheathing in the attic, likely from before the roof was replaced. I recommend monitoring these areas for further staining.

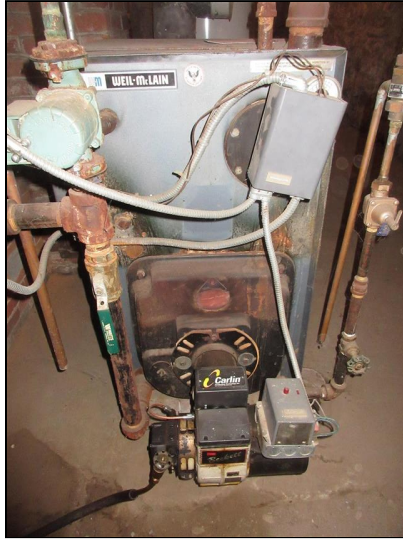
(1) The boiler was manufactured in 1989. This boiler is 28 years old and approaching the end of its service life. I recommend planning for replacement of the boiler.

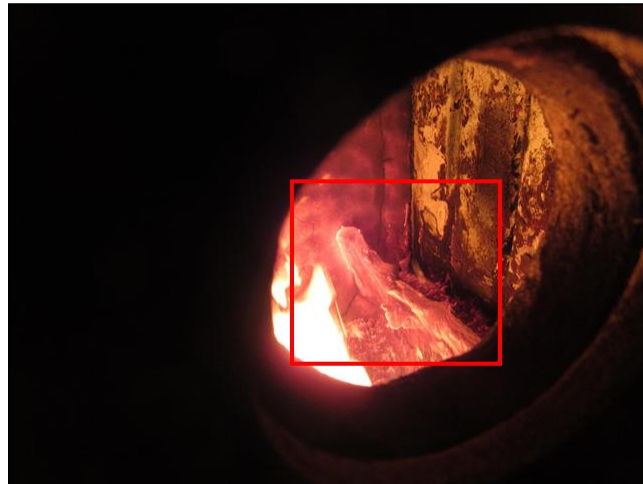
🔧 (3) The ceramic material at the back of the combustion chamber for the boiler was deteriorated. The oil-fired burner may create hot spots on the heat exchanger and cause premature failure. I recommend that the boiler be repaired or replaced.

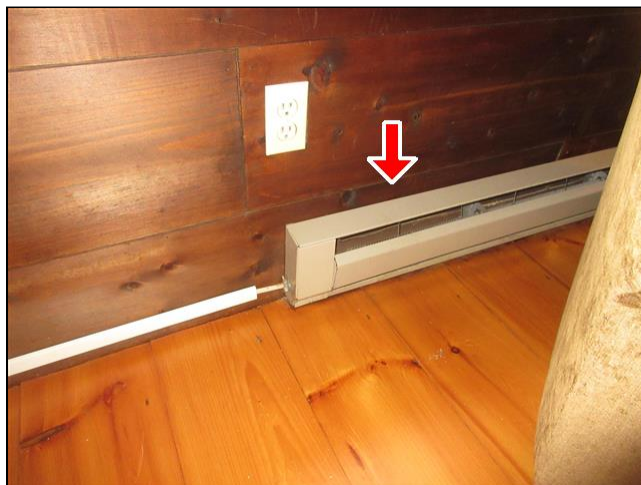
✚ (4) The family room in the former carriage house was heated with electric baseboard convectors. These units can get very hot, creating a fire hazard. Care should be taken to keep flammable items away from the electric baseboard convectors; this includes electrical cords.

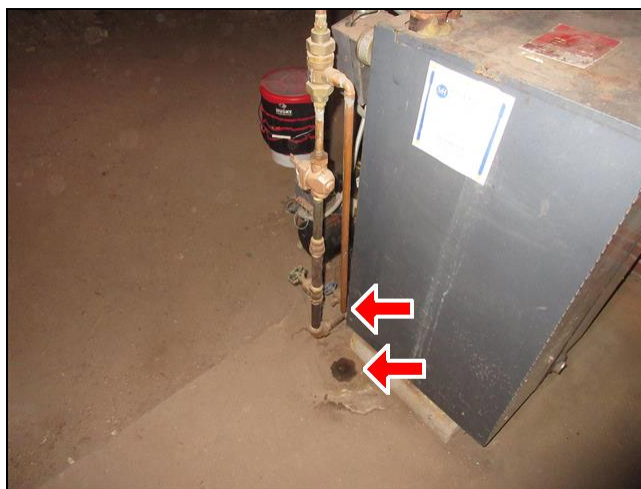
🔧 The backflow preventer extension for the boiler was dripping on the floor. If the boiler is working properly water should not leak out of this pipe. A heating system technician should service the boiler and make repairs as needed.

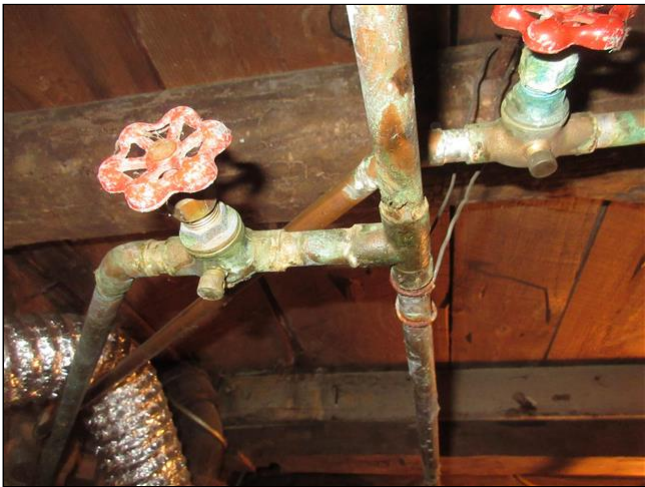
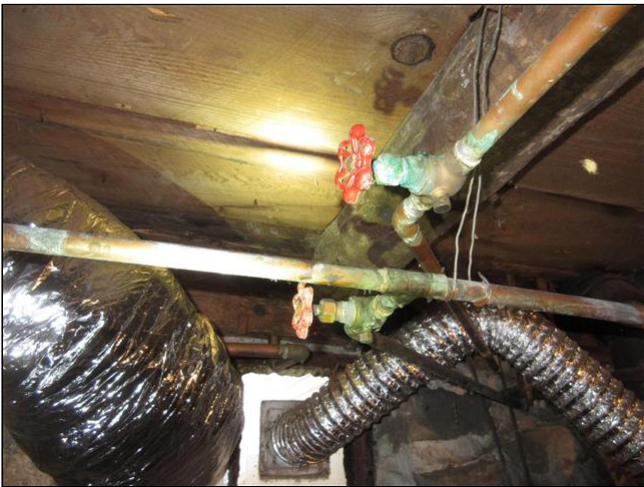
🔧 (1) There were corroded water supply pipes and valves in the basement and under the sinks. There is the potential for leaks. I recommend repair by a licensed plumber. There is the potential for deteriorated pipes in concealed areas of the building.

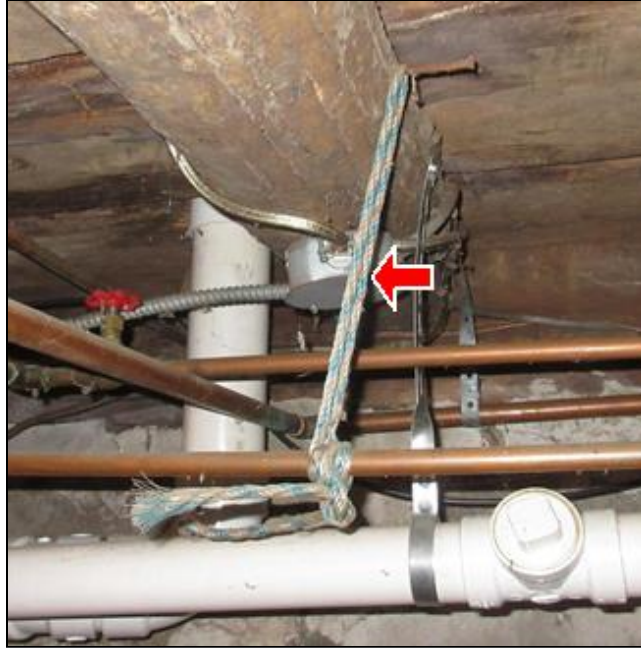
- 🔧 (2) There were poorly supported pipes in the basement. These pipes should be properly secured in place.

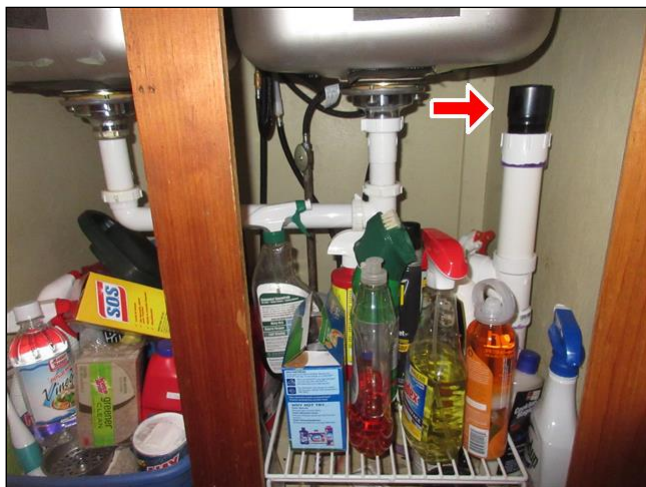
Internal vent at kitchen sink

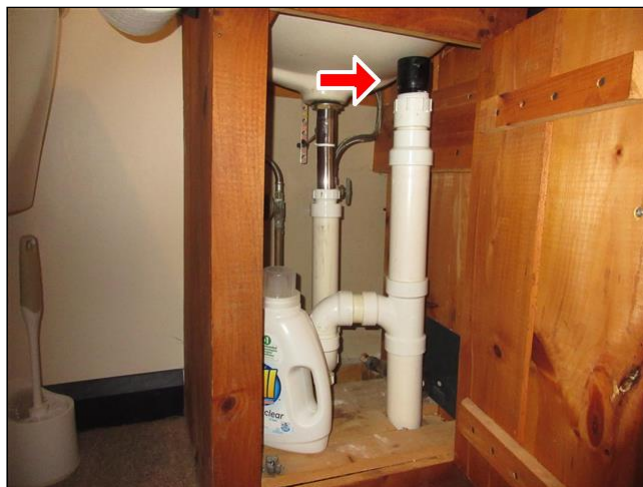
Internal vent at first floor bathroom sink

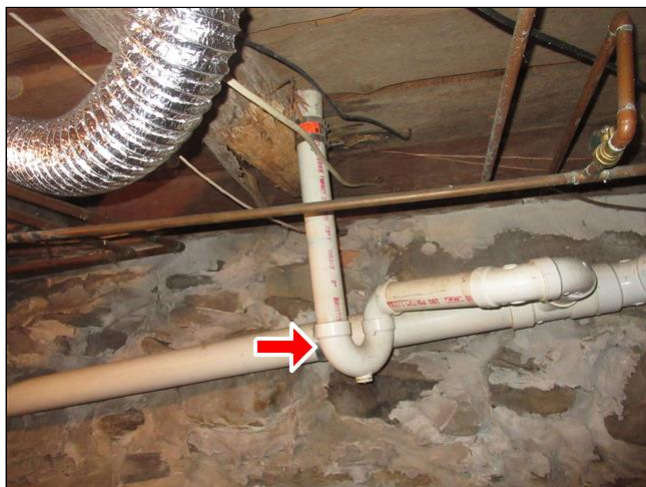
The trap for the washing machine standpipe and the second floor bathroom sink were not vented. It is likely that the bathtub drain is not vented. This is an unsanitary condition. The traps can siphon dry and allow sewer gas to enter the living space.

Unvented trap for washing machine

I recommend that a licensed plumber install proper venting for all of the drains.

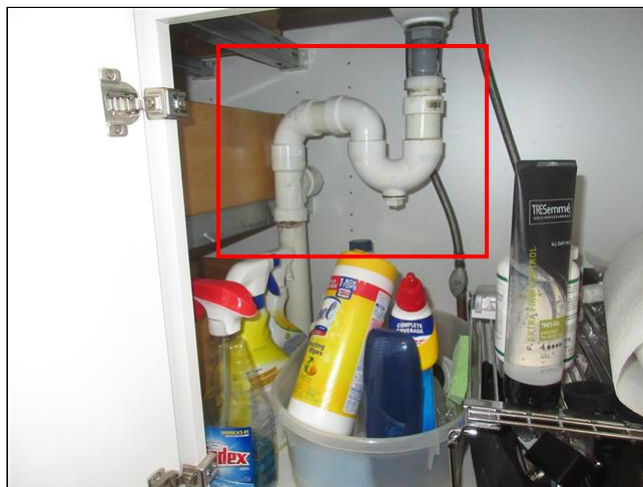
Unvented S trap at second floor bathroom sink drain

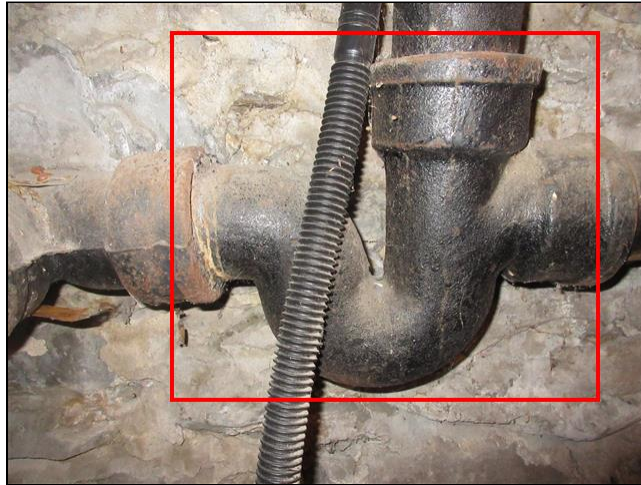
🔧 (4) The house was equipped with a whole house trap. These are no longer used as they can easily clog. The pipe should be monitored for clogs. If found to clog frequently I recommend that the whole house trap be removed by a licensed plumber.

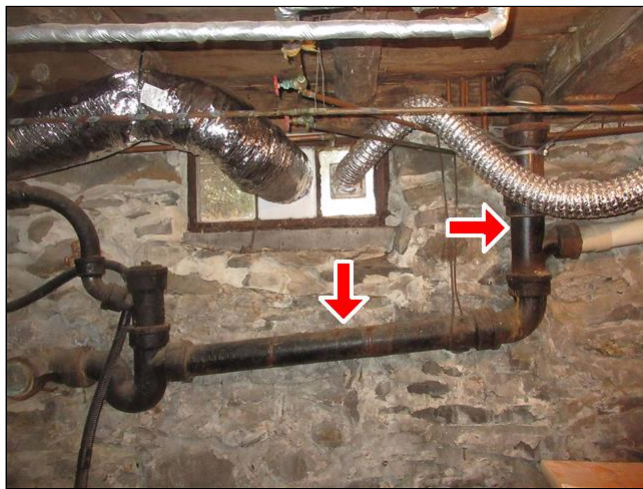
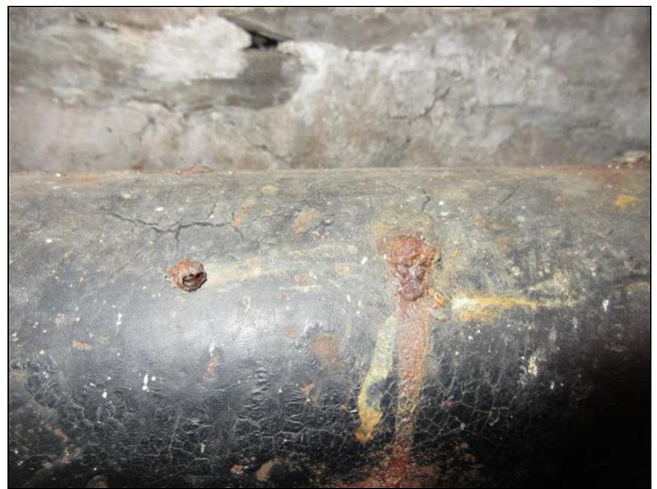
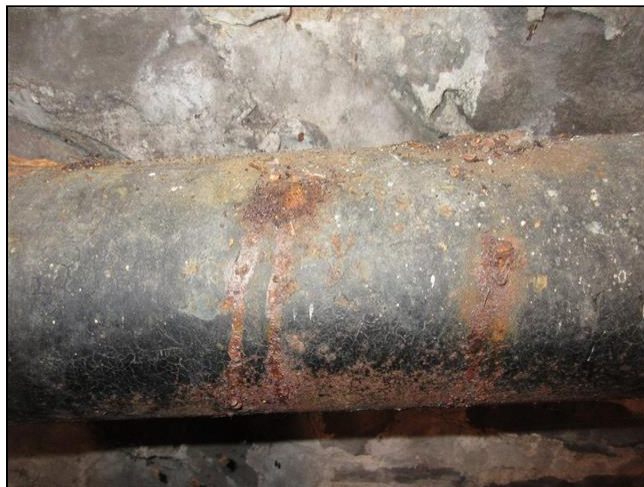
🔧 (5) The main waste piping was cast iron. Some of these pipes were corroded. There were pinhole leaks in the pipes in the basement. I recommend repair by a licensed plumber. There is the potential for deteriorated iron waste pipes in concealed areas of the building.

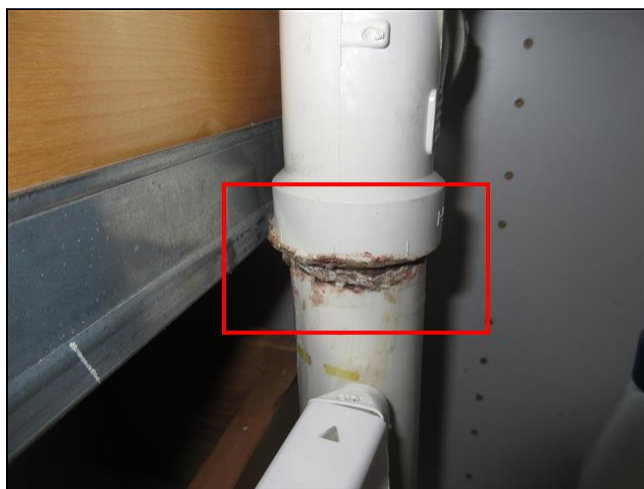
🔧 (6) There was a leak at the drain for the second floor bathroom sink. A licensed plumber should repair this pipe.

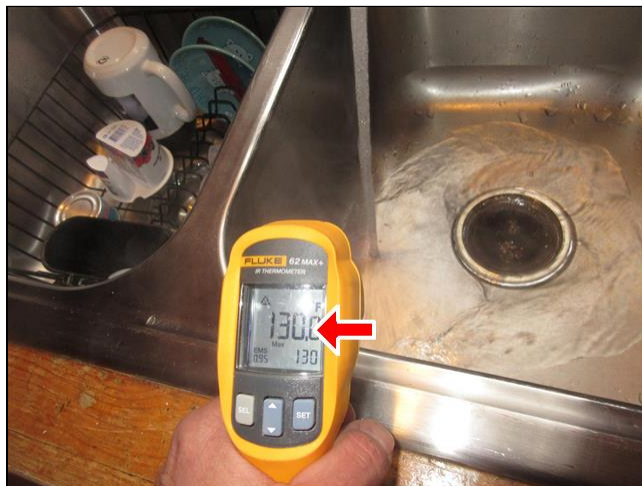
**+** The hot water was set to 130 degrees Fahrenheit. This is a safety hazard, especially when small children are present. I recommend that the hot water be set to 120 degrees Fahrenheit.

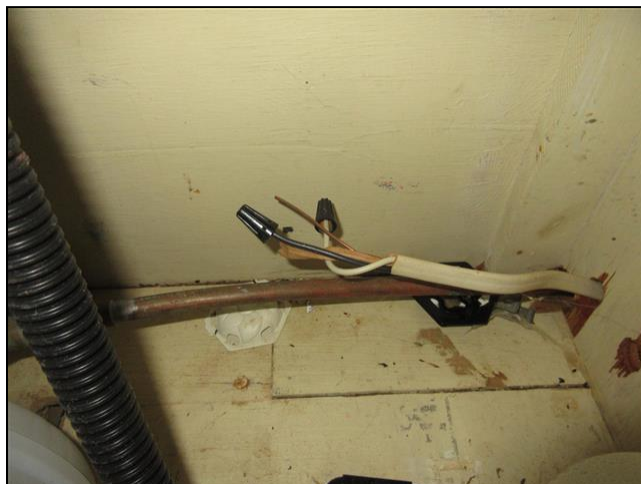
✚ There was a loose wire under the kitchen sink that was not terminated in a junction box. This is safety hazard. A licensed electrician should remove or properly terminate this wire.

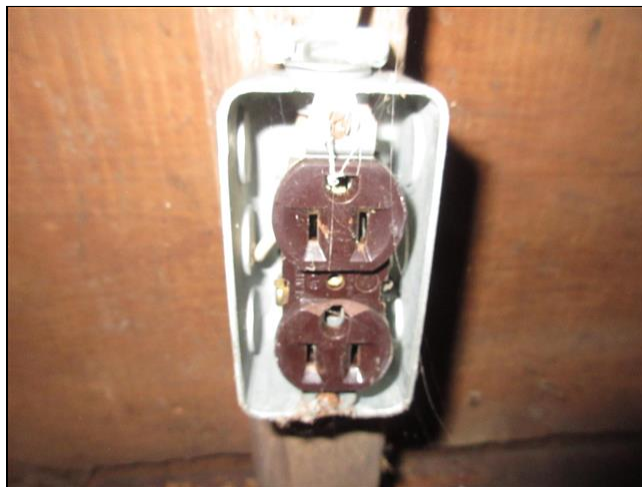
⚠ (2) There was a missing cover plate at a receptacle in the basement. There were live wires exposed at this location. A cover plate should be installed.

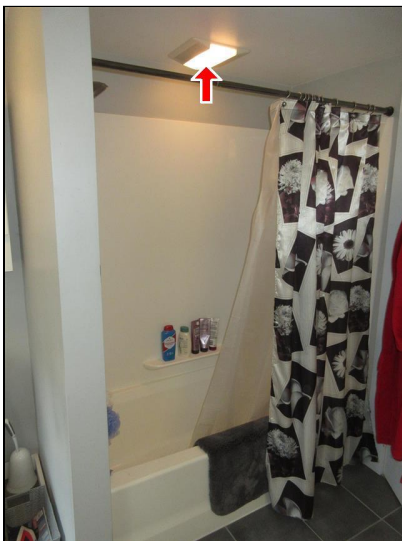
⚠ (3) The exhaust fan in the second floor bathroom was installed in the shower enclosure. When fans are located in a shower enclosure they should be GFCI protected. This fan should be re-wired on a GFCI circuit.

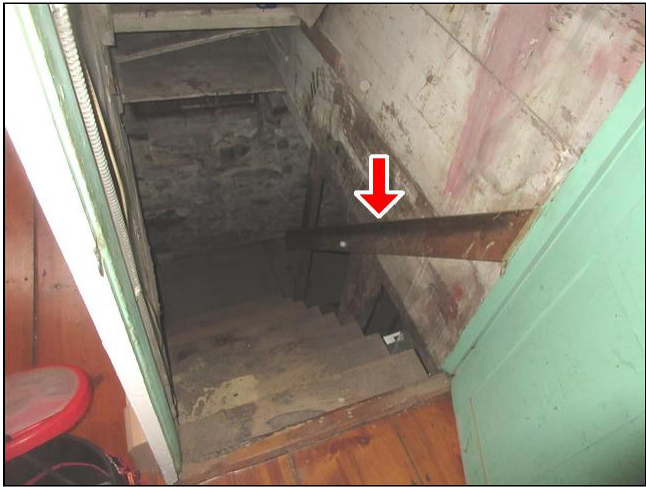
**+** (1) The hand railing at the basement stairs was not graspable. This hand railing was constructed of a board turned on its side. All hand railings should be graspable for safety. This hand railing should be repaired or replaced.

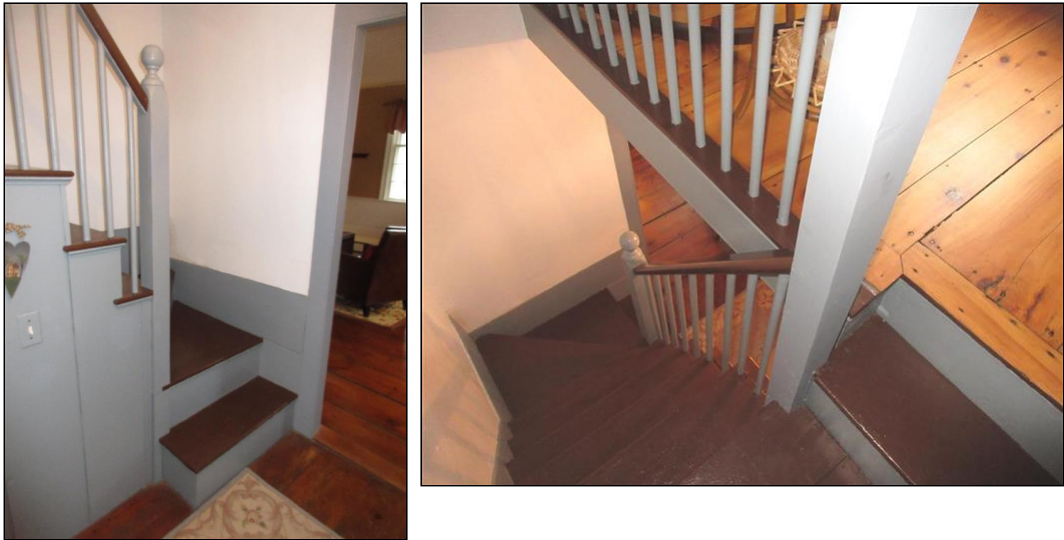
**+** (2) The railings at the two sets of stairs to the second floor were not continuous. Railings should run continuously from the bottom of a staircase to the top. Proper railings should be installed at these staircases.

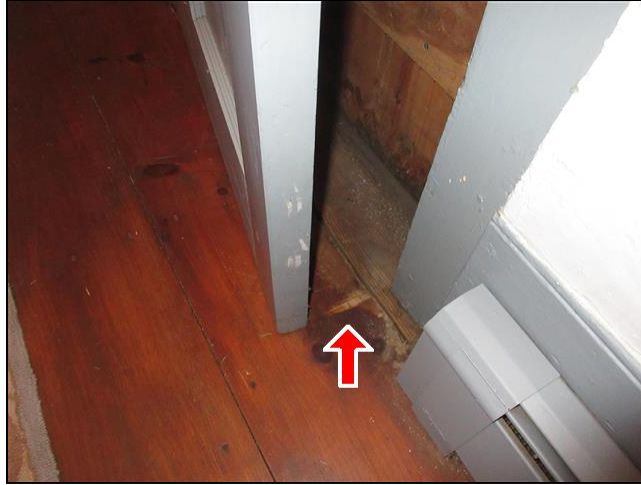
🔧 (2) The front door did not close easily as it dragged on the floor. The door should be adjusted so that it closes properly.

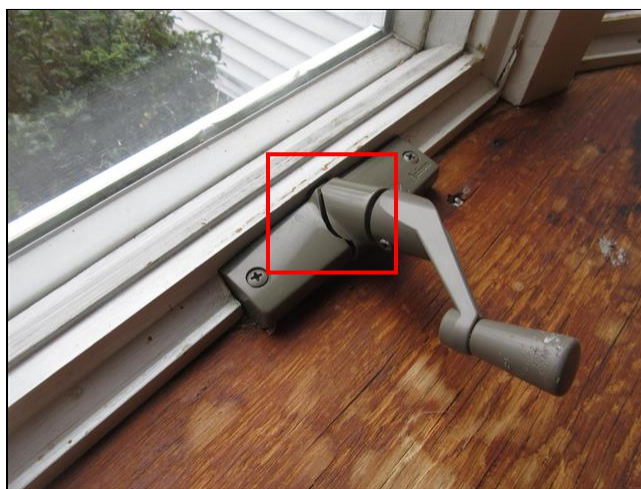
🔧 (4) The crank mechanism at one of the casement windows at the bay window was broken. The window would not open. This mechanism should be replaced.

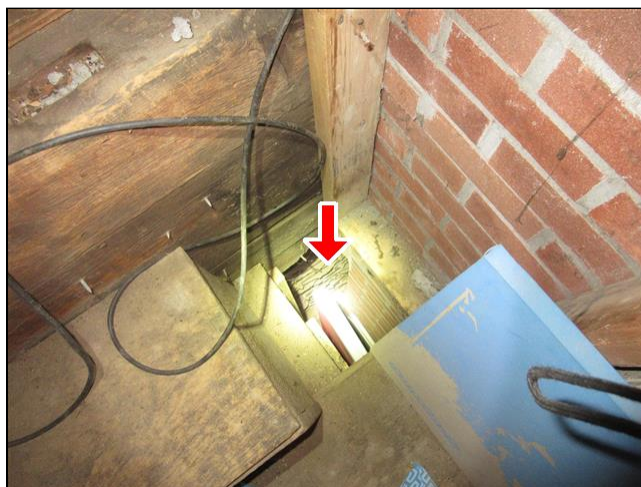
⚠️ There was an open chase adjacent to the chimney in the former carriage house. Fires can spread easily through a house up an open chase. Open chases also reduce the energy efficiency of the house. This chase should be properly sealed off.

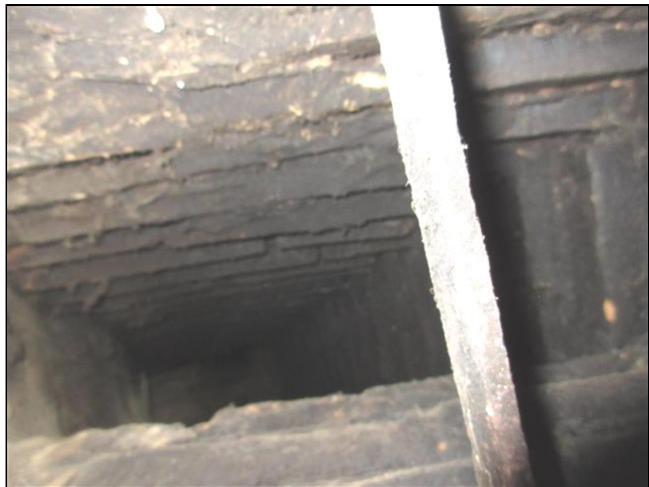
The fireplaces vented into unlined flues. There is the potential for combustion gases to leak through gaps in the brick and then into the house. These gases may contain carbon monoxide.

Unlined flue, no damper

I recommend further inspection of the chimney and fireplaces by a qualified chimney sweep. I recommend level 2 chimney inspections, where the chimney sweep uses a video camera to inspect the full length of the flues.

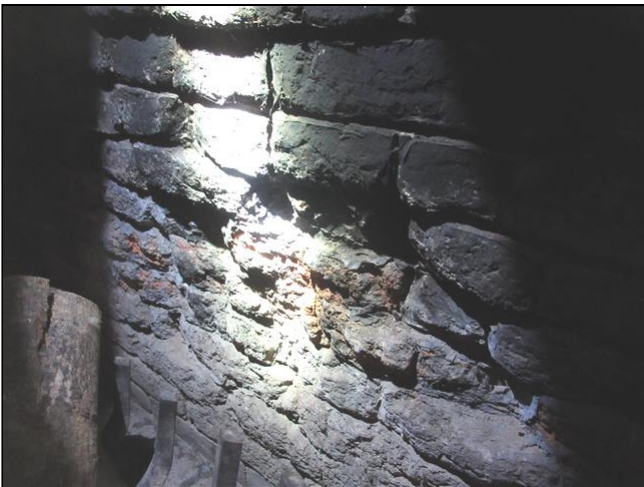
There was deteriorated masonry at the back of the fireboxes.

Deteriorated masonry at the back of the kitchen fireplace

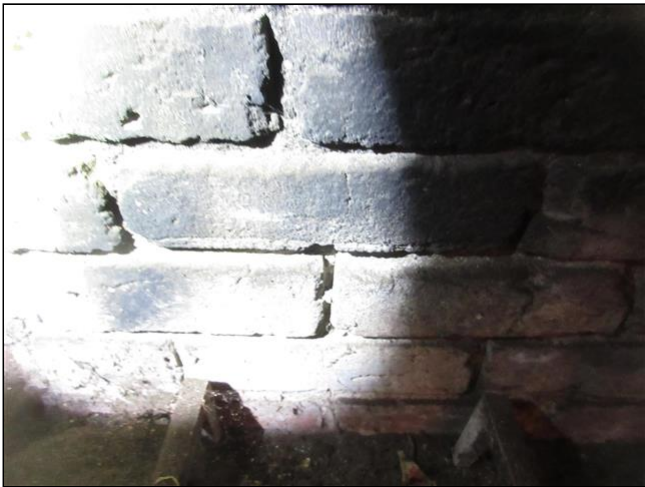
Deteriorated masonry at the back of the dining room fireplace
