# Inspection Report

123 Main Street  
Anytown MA

**Still River Home Inspections, Inc.**

| Date: 9/7/2017 | Time: 09:00 AM - 12:30 PM | Report ID: 030717 sample |

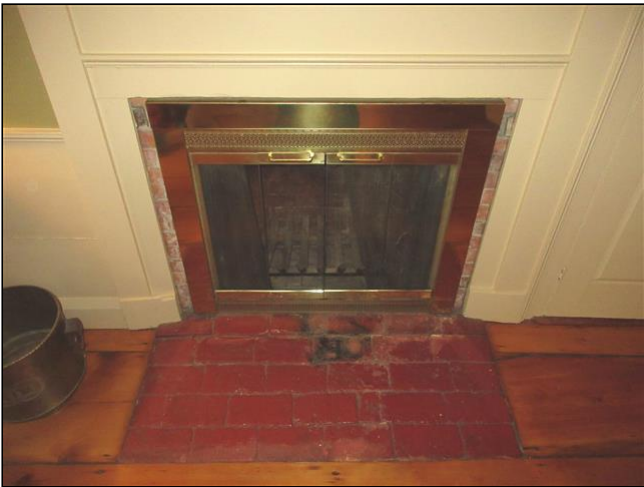
Wood too close to firebox

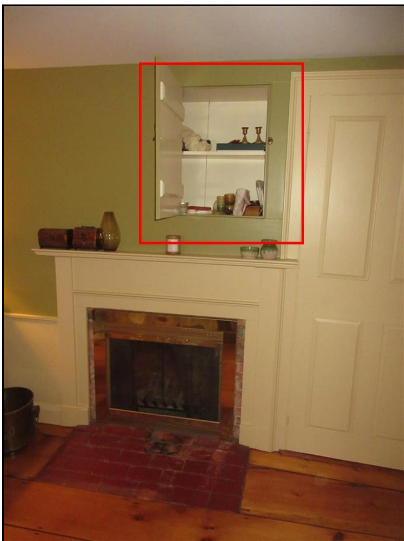
Wood in cabinet too close to the chimney

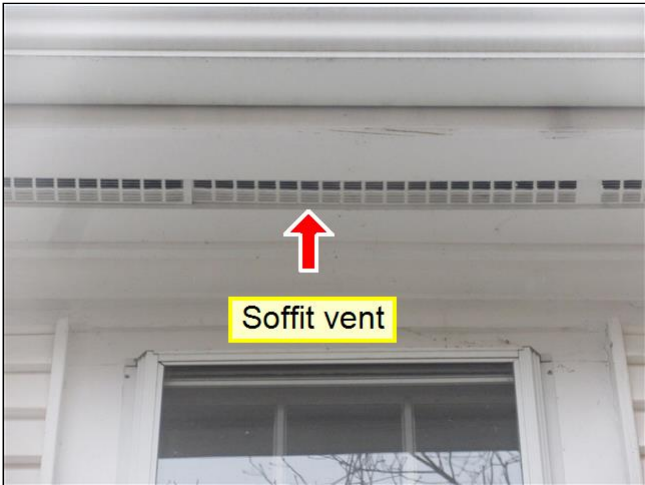
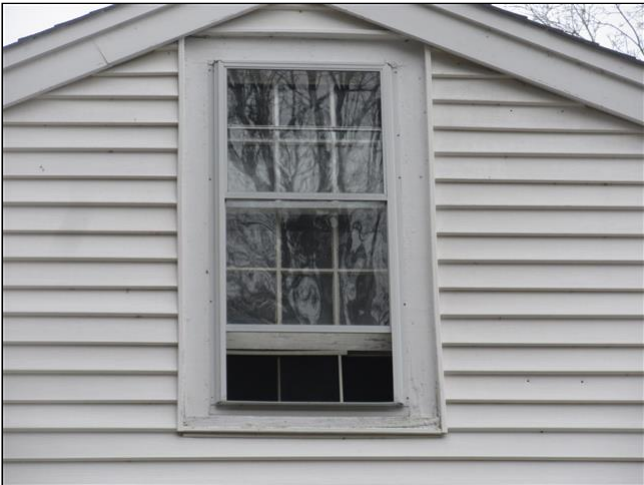
Venting to the attic was supplied with soffit vents but no gable or ridge vents. Proper venting in the attic decreases the chance of ice dam formation, keeps the house cooler in summer, and decreases the chance of mold in the attic. The windows at both ends of the attic had been left open to provide additional venting. There is the potential for wind driven rain to enter these windows. I recommend that a qualified contractor install roof and/ or gable vents (adding ridge vents would not be practical due to the post and beam structure in the attic).

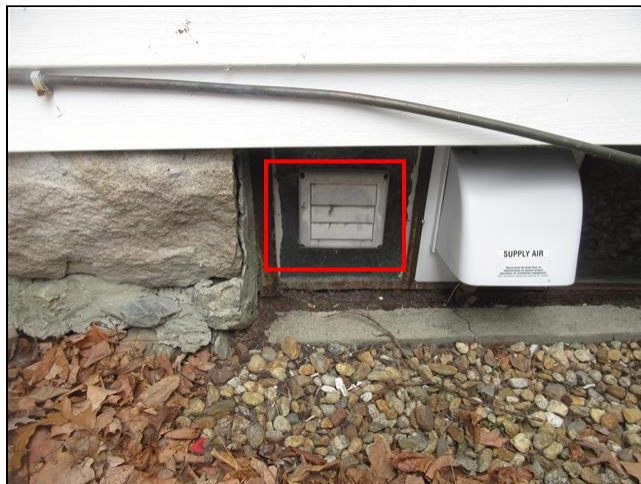
⚠️ (2) The dryer vent hood was close to the ground. If this vent hood gets covered with snow, lint may build up in the dryer and dryer vent duct. This is a fire hazard. This vent hood should be kept clear of snow and other debris.

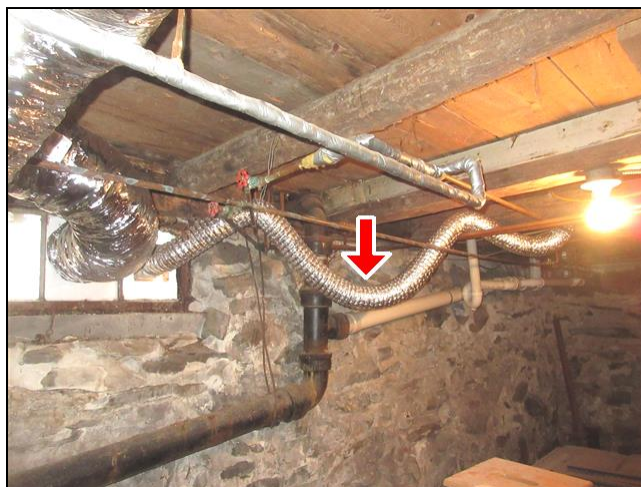
⚠️ (3) There was a long run of dryer vent duct running from the dryer to the dryer vent hood on the exterior of the house. In long runs of dryer vent duct, there is the potential for lint to build up in the duct. There were low points in the dryer vent duct that increase the likelihood of lint build up. Lint build up in a dryer vent duct is a fire hazard. I recommend that a duct cleaning company clean out this duct on a periodic basis.

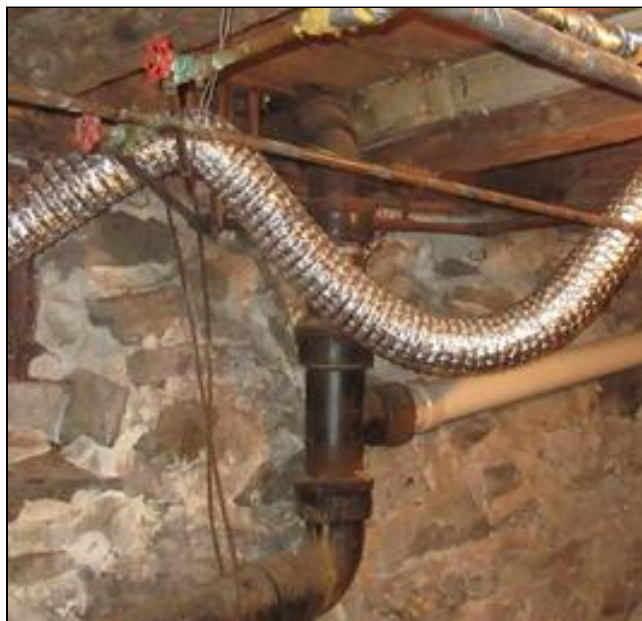
✚ (4) The dryer vent duct was a flexible metal vent duct. There is the potential for lint to build up in the duct. Lint build up in a dryer vent duct is a fire hazard. The dryer vent duct should be replaced with stiff metal vent pipe, with as few bends as possible.
