Inspection Report

123 Main Street
Anytown MA

Still River Home Inspections, Inc.

| Date: 10/23/2017 | Time: 09:00 AM - 12:00 PM | Report ID: 082817 sample |

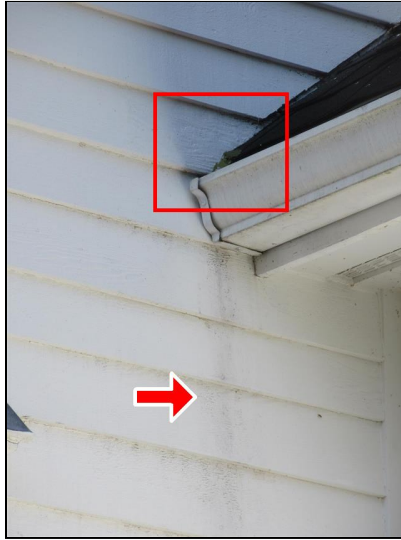
🔧 (1) There was no kick out flashing between sections of the roof and the side walls of the house. Kick out flashing diverts water out and away from the side of the house. This prevents water from running down in front of and behind the siding, which can cause decay and damage. A licensed roofer or siding contractor should install kick flashing.

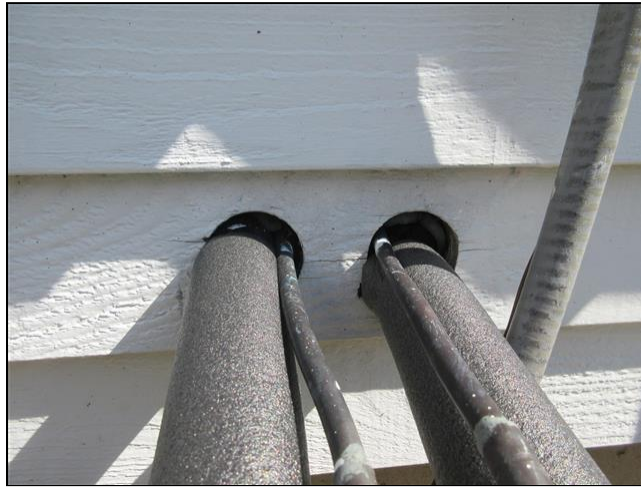
🔧 There were gaps around the AC refrigerant lines where they passed from the compressor/ condenser units through the side of the house. These gaps will reduce the energy efficiency of the house and may enable pests to enter the house. These gaps should be properly sealed.

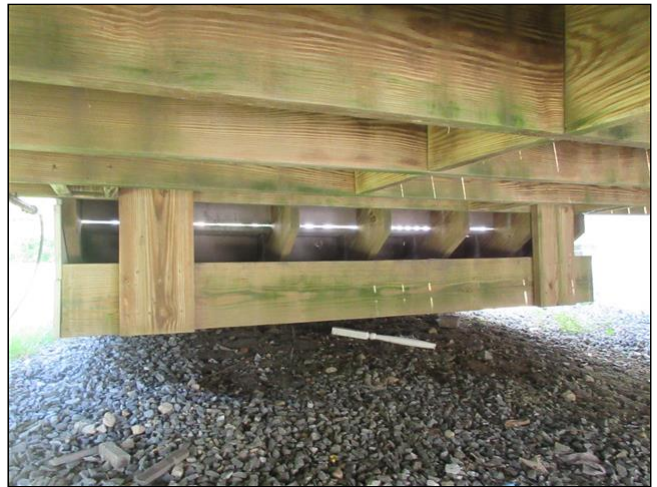
Lower deck and steps hung from a single joist at the upper deck

I recommend that a qualified contractor complete these repairs.

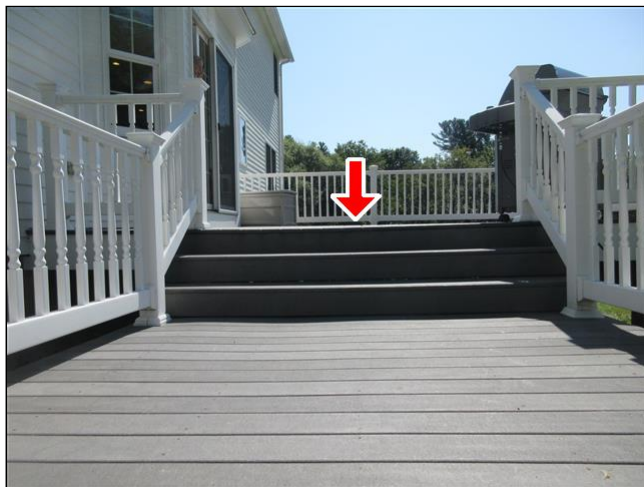
Upper deck bowed downwards

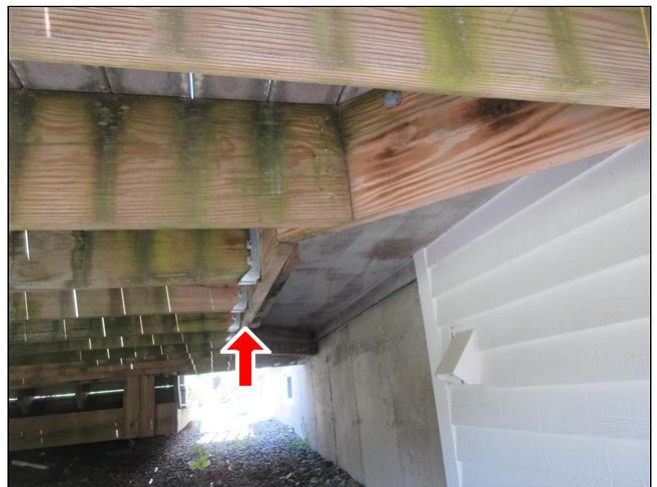
The ledger board at the upper deck was bolted to the house rim joist at the overhang at the back of the house. Due to the overhang, the house rim joist is not supported on a concrete foundation or studs in a wall. Instead the house rim joist is nailed into the ends of house floor joists. This connection is not sufficient to support heavy loads on the deck. Concrete piers and posts should be installed under this area.

Ledger board attached to house overhang

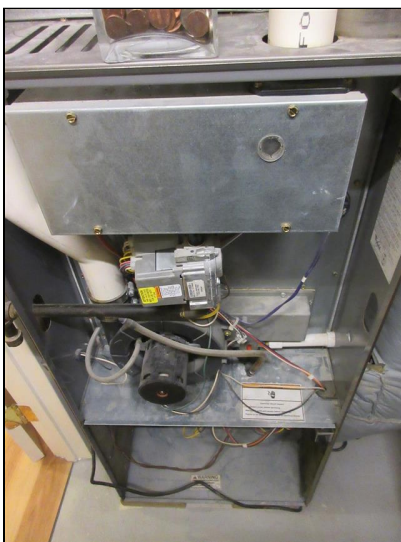
(1) The furnaces were the original furnaces from when the house was built in 2004. This is for your information.

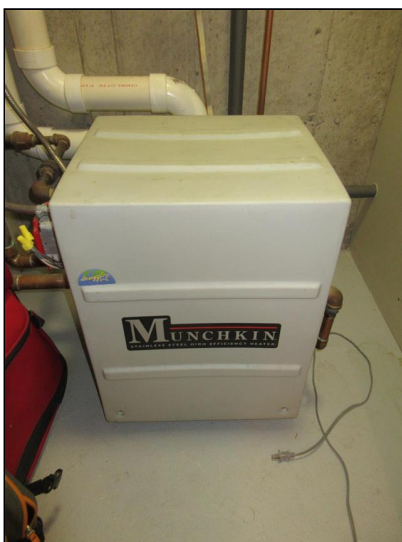
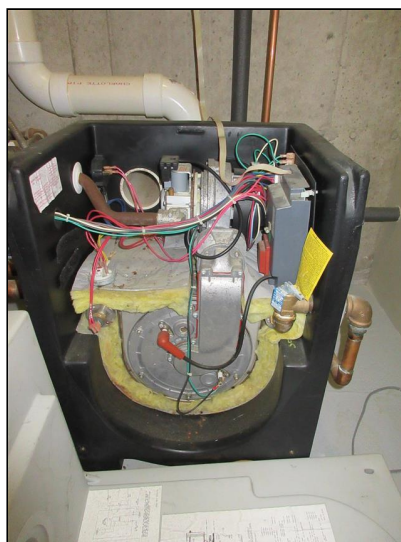
(2) The boiler was manufactured in May 2005. This is for your information.

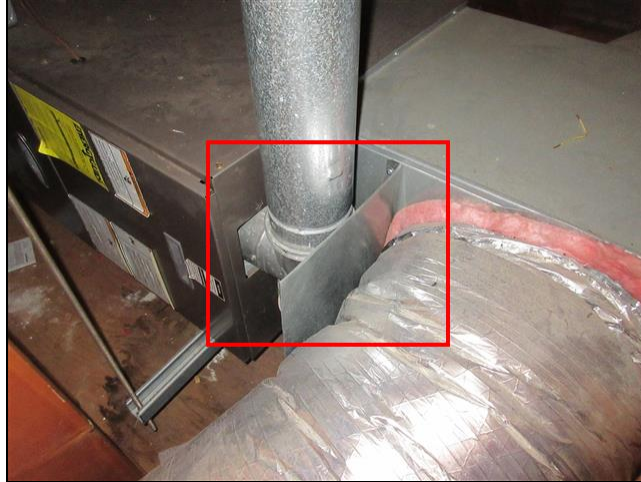
+ There was insufficient clearance between the metal chimney at the attic furnace and the plastic wrapping on the insulation on the duct next to it. This is a fire hazard. I recommend repair by an HVAC technician.

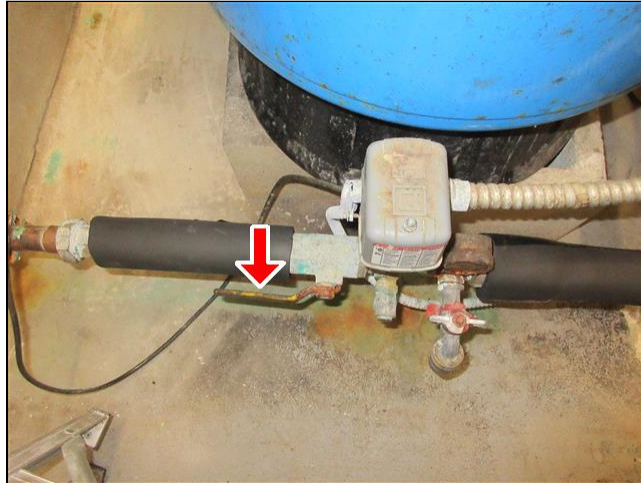
The main water shut off was located at the well tank. This is for your information.

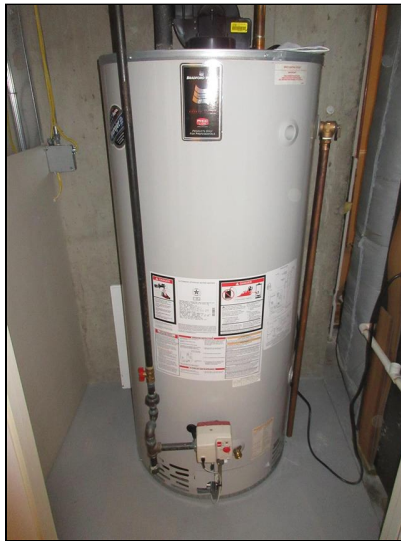
The water heater was manufactured in April 2012. This is for your information.

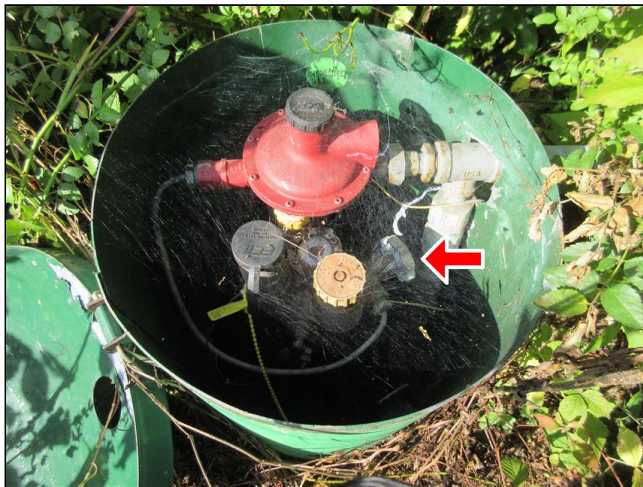
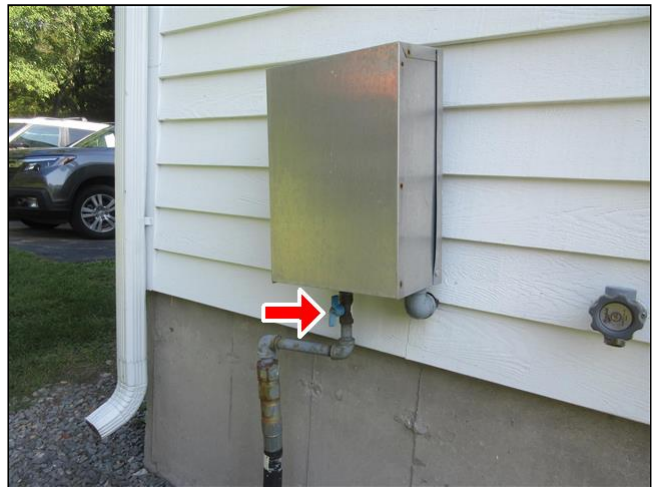
The main propane shut offs were located at the propane tank and at the regulator at the back of the house. This is for your information.

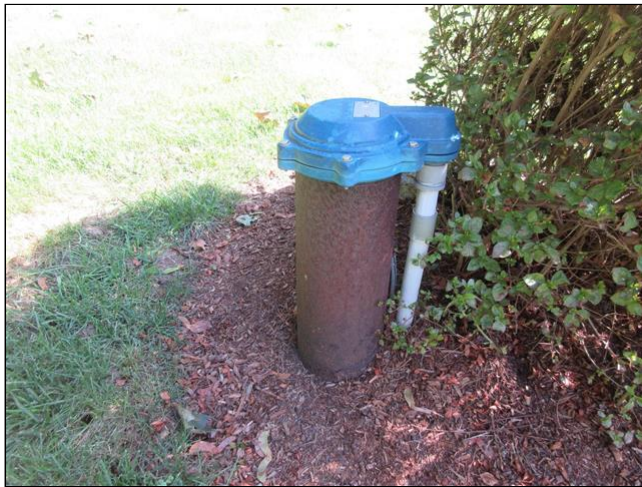
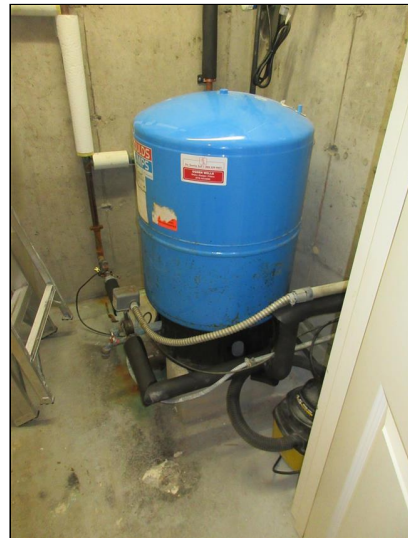
(1) The well, well pump, well tank, and the line from the well pump to the well tank were out of scope for this home inspection and were not inspected.

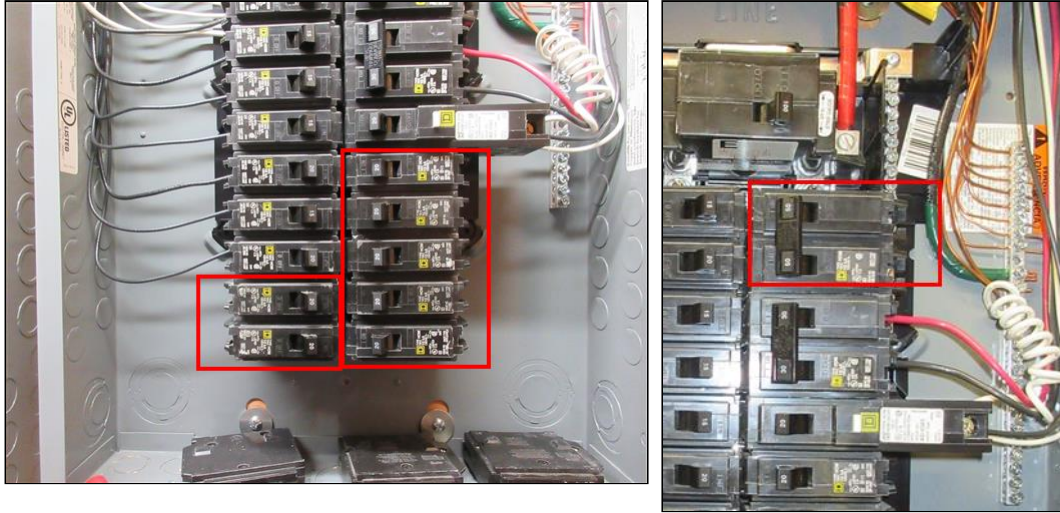
(2) There were a number of unused, spare breakers in the smaller sub panel. These breakers should be shut off.

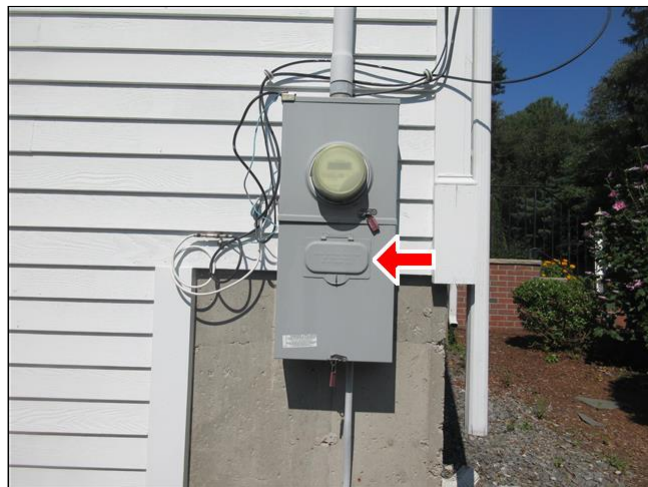
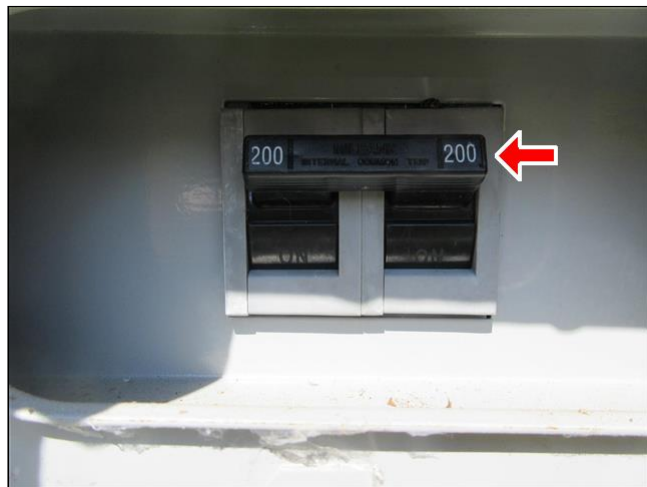
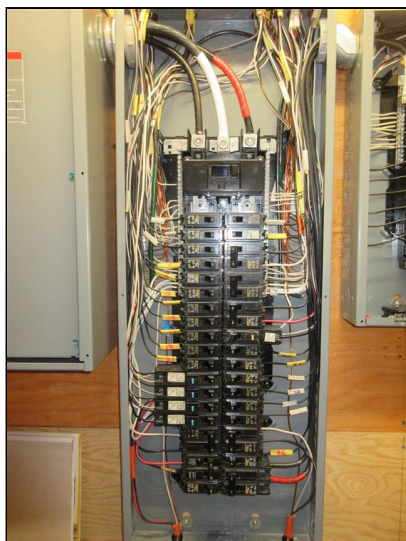
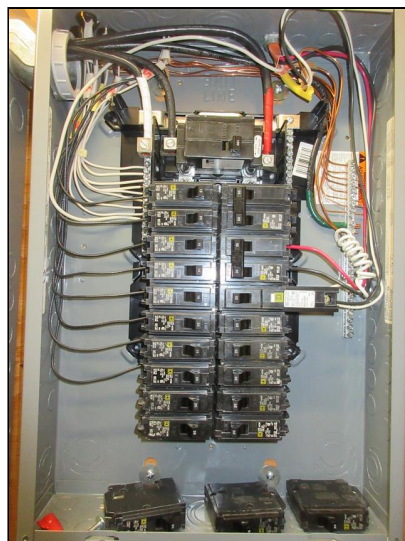
(1) The main electric shut off was located at the exterior of the left front corner of the house. There were two sub panels at the front of the basement. This is for your information.

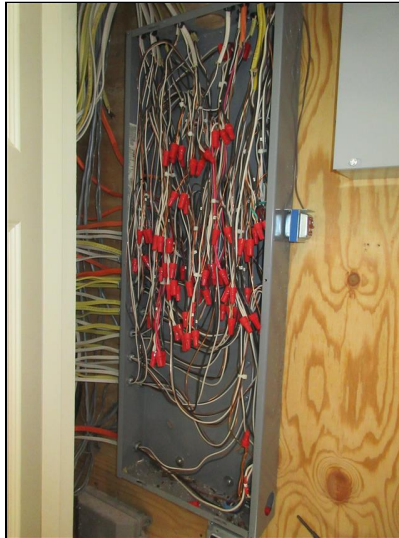
(2) The original main electric panel had been converted into a large junction box. This is for your information.

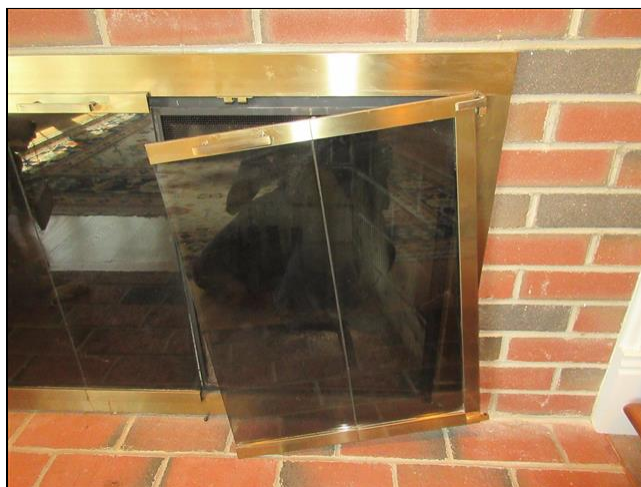
🔧 One of the doors at the fireplace was loose. A qualified contractor should repair this door. The glass doors should be kept open and the screens should be kept closed when a fire is burning in the fireplace.

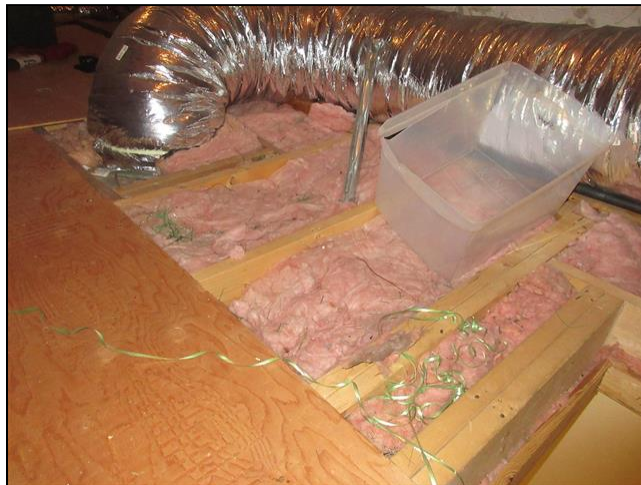
🔧 (1) There was less insulation in the attic than required for optimal energy efficiency. The tops of floor joists were exposed. There will be heat loss in the cold weather. Today's standards call for R-37-R-49 in the attic. This is roughly 12-18 inches of fiberglass or cellulose insulation. Proper insulation increases the energy efficiency of the house, keeps the house cooler in summer, and reduces the chance of ice dams. I recommend a Mass Save energy audit (masssave.com). The Mass Save program may provide significant rebates for work to improve the energy efficiency of the house. Adding insulation to the attic will require that the plywood floor be removed or raised.

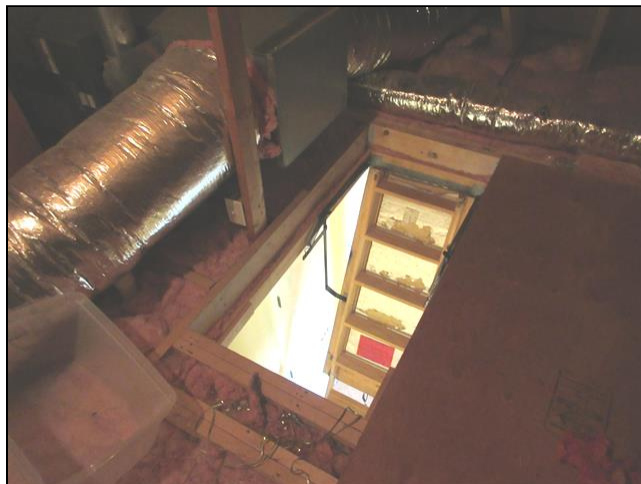
🔧 (3) Access to the attic was gained from pull down stairs. These stairs will contribute to heat loss during the heating season. A foam board insulation box should be installed above the pull down stairs, with weatherstripping installed between the insulation box and the attic floor. This will help to prevent heat loss and ice damming and will reduce energy costs.

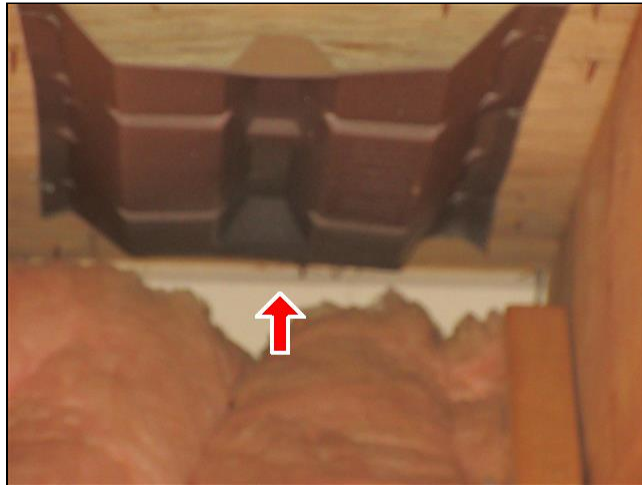
🔧 In the attic, some of the rafter chutes were improperly installed. There were gaps at the bottoms of the rafter chutes. If insulation is added to the attic, the insulation will block the soffit vents. An insulation and ventilation company should replace the rafter chutes.

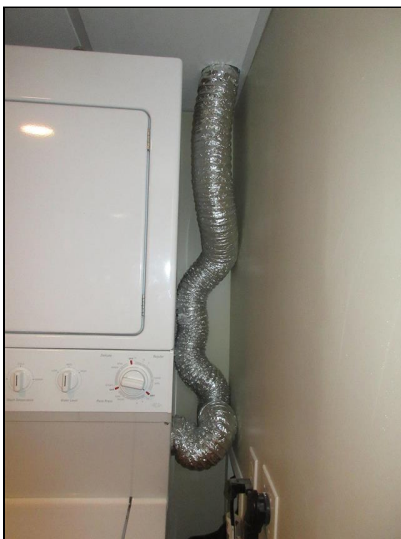
⚠ (2) The dryer vent duct connector was scrunched up. There is the potential for lint to build up in the duct. Lint build up in a dryer vent duct is a fire hazard. The dryer vent duct should be replaced with a properly installed UL listed dryer vent duct connector.

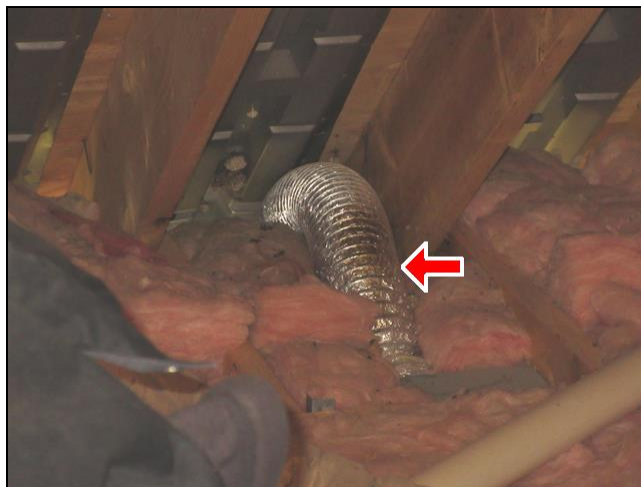
🔧 (4) The bathroom exhaust fan ducts were not insulated in the attic. There is the potential for condensation build up in the ducts. An insulation and ventilation company should replace these ducts with insulated ducts.
