# Inspection Report

123 Main Street  
Anytown MA

**Still River Home Inspections, Inc.**

| Date: 9/7/2017 | Time: 09:00 AM - 12:30 PM | Report ID: 030717 sample |

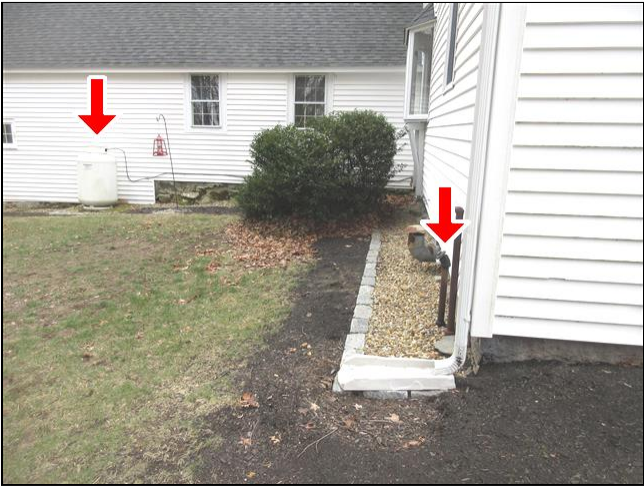
2.12 OTHER

The oil fill pipe and propane tank were located away from the driveway. After heavy snow storms, it may be necessary to shovel a path to the fill pipe and the propane tank so that the oil and propane companies can make deliveries. This is for your information.

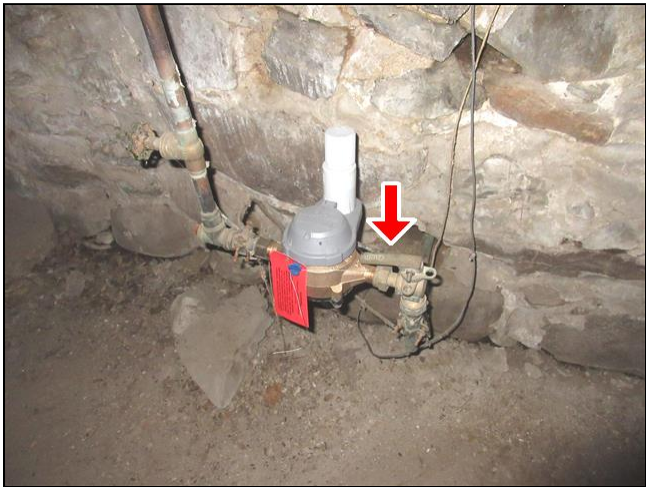
5.0 MAIN WATER SHUT-OFF VALVE

The main water shut off was located at the water meter at the front of the basement. This is for your information.

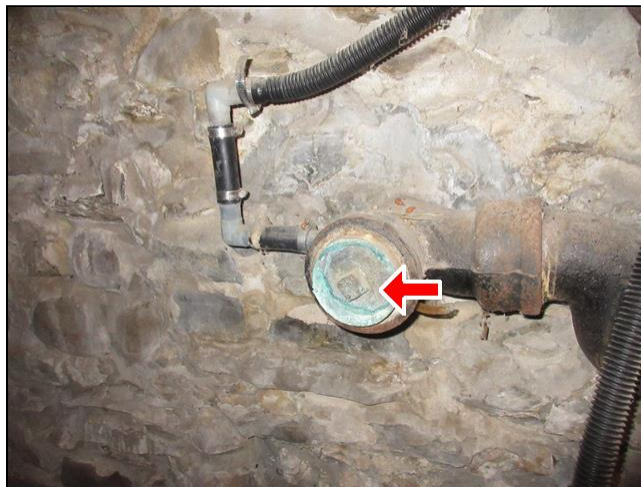
- (1) The main sewer clean out was located at the back of the basement. This is for your information.

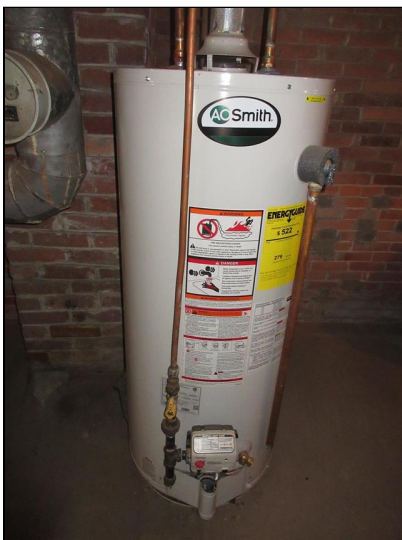
## 5.5 WATER HEATER - EQUIPMENT

The water heater was manufactured in October 2013. This is for your information.

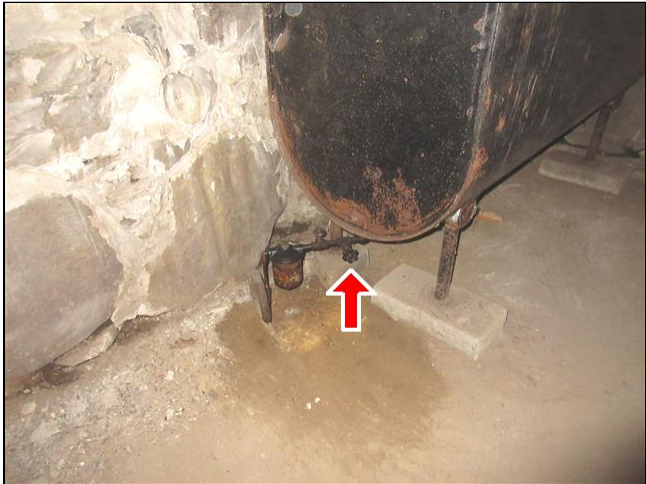
(1) The main oil shut off was located at the oil tank. This is for your information.
